# Preliminary Site Investigation

**Cashmere Road - Sparks Road -  
Northaw Street - Leistrella Road, Hoon  
Hay, Christchurch**

Prepared for Cashmere Private Plan Change  
(CPPC)  
511270

**eliot  
sinclair**

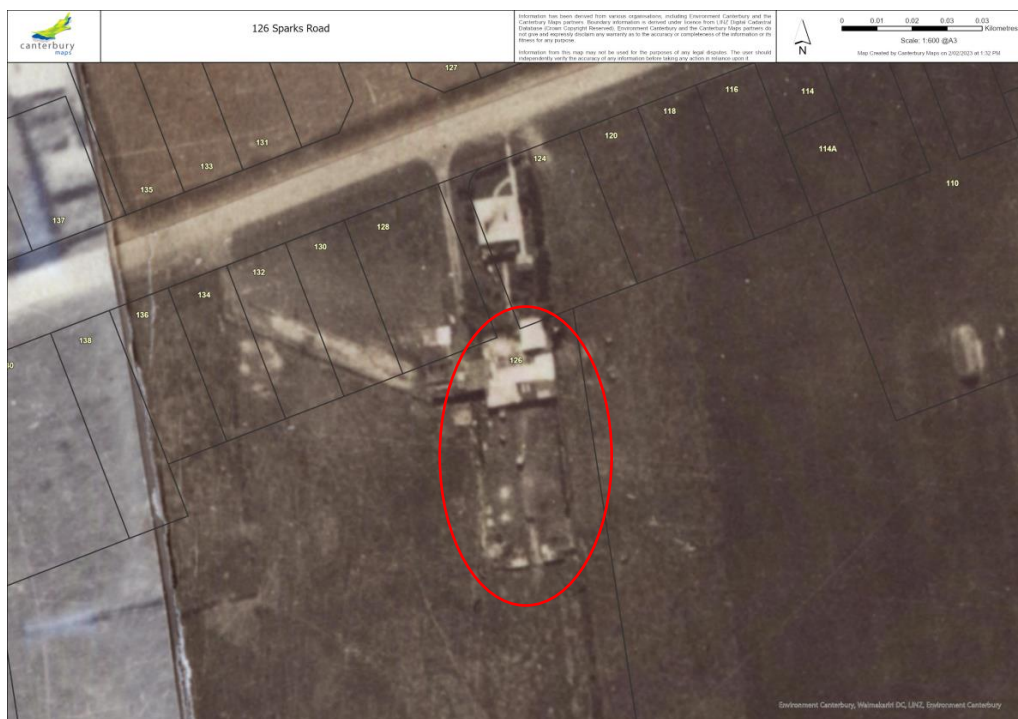
**Figure 4. 126 Sparks Road between 1925-1929 (Canterbury Maps).**

Figure 4 contains the first available aerial photo of the site, and shows the presence of a house on 126 Sparks Road. Given the house was constructed before 1925, the presence of contaminants like asbestos and lead-based paint cannot be ruled out. The later demolition of that building potentially released contaminants to the soil (**HAIL I**). The entire site seems to be used for agricultural/pastoral activities which potentially involved the use of persistent pesticides (**HAIL A10**).

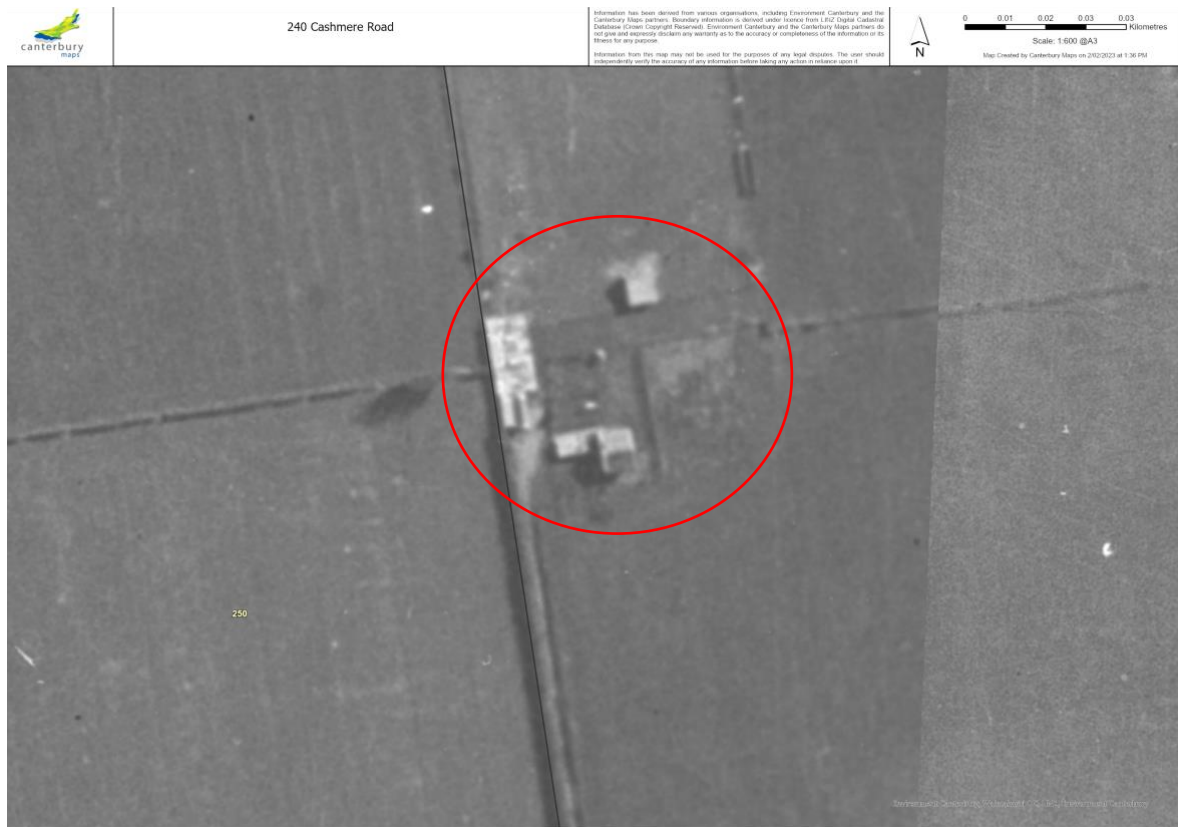
**Figure 5. 240 Cashmere Road between 1940-1944 (Canterbury Maps).**

Similarly, Figure 5 shows the first appearance of a house on 240 Cashmere Road. Due to the date of its construction – prior to 1944, the risks of soil contamination by asbestos (**HAIL E1**) and lead-based paint (**HAIL I**) exist. Although this cannot be confirmed, the likelihood of that building to have been a “shearing” shed or a building used for an activity related to sheep/cattle treatment cannot be ruled out, particularly the structure on the west side of the building which could have been part of a sheep dip. This activity would be related to **HAIL A8**: Livestock dip or spray race operations.

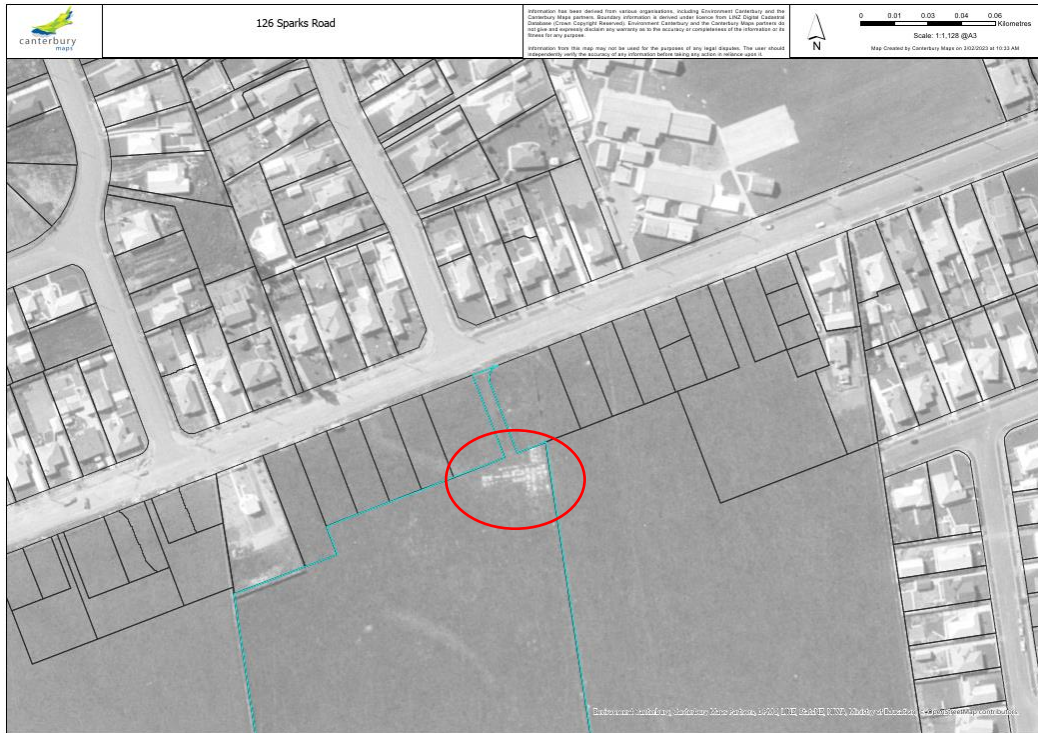
**Figure 6. 126 Sparks Road between 1965-1969 (Canterbury Maps).**

The house seen on 126 Sparks Road appears to have been removed in the historic aerial photograph displayed in Figure 6. The demolition of this house could be classified under **HAIL I**: “land subjected to accidental release of a hazardous substance in sufficient quantity that it could be a risk to human health or the environment”. The area remaining in and surrounding the house footprint, has potential for **heavy metal (lead-based paint)** and **asbestos** contamination.

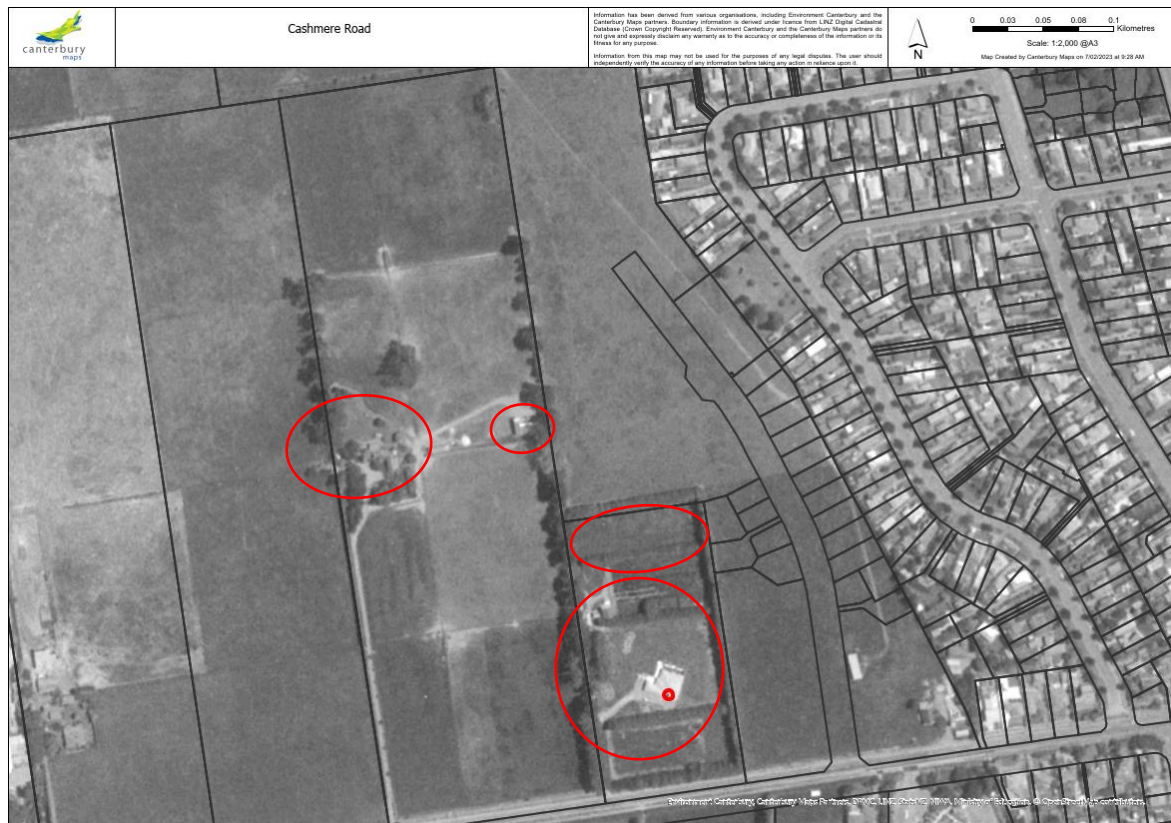
**Figure 7. Site 1990-1994 (Canterbury Maps).**

Figure 7 shows the presence of new buildings located at both 236 and 240 Cashmere Road and the start of additional horticultural activities that may have involved the use of persistent pesticides.

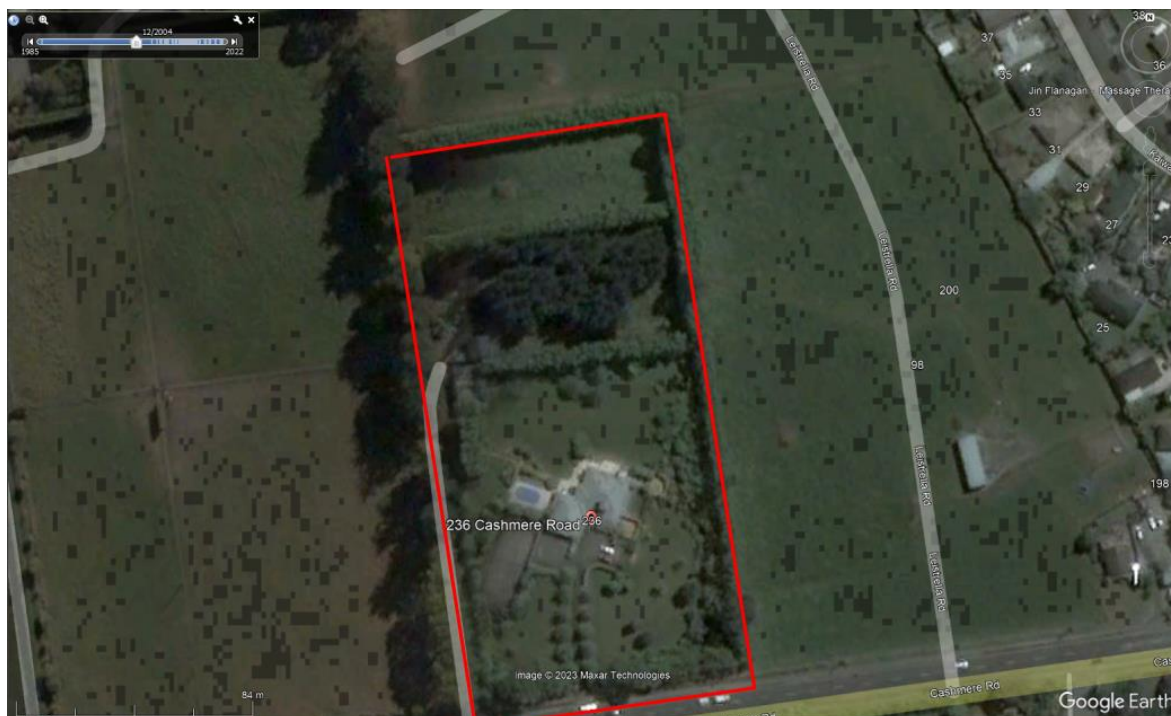
**Figure 8. Site 2000-2004 (Google Earth Pro).**

Figure 8 shows the presence of new or upgraded buildings at 236 Cashmere Road alongside continued horticultural activities that may have involved the use of persistent pesticides.

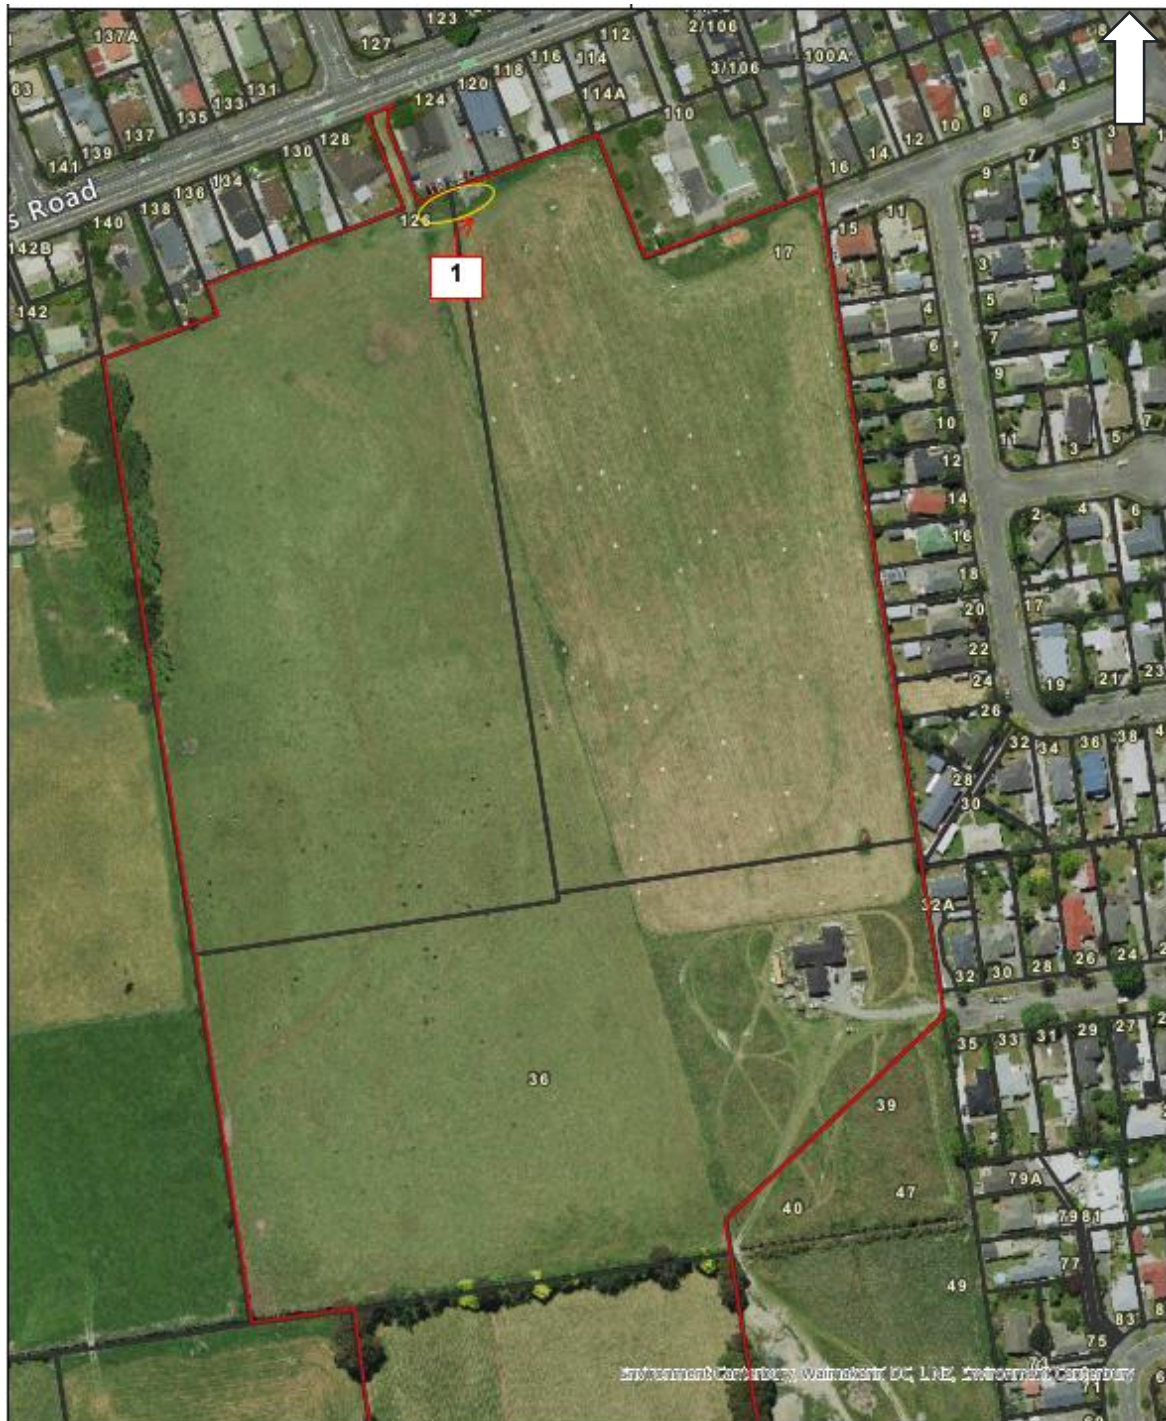
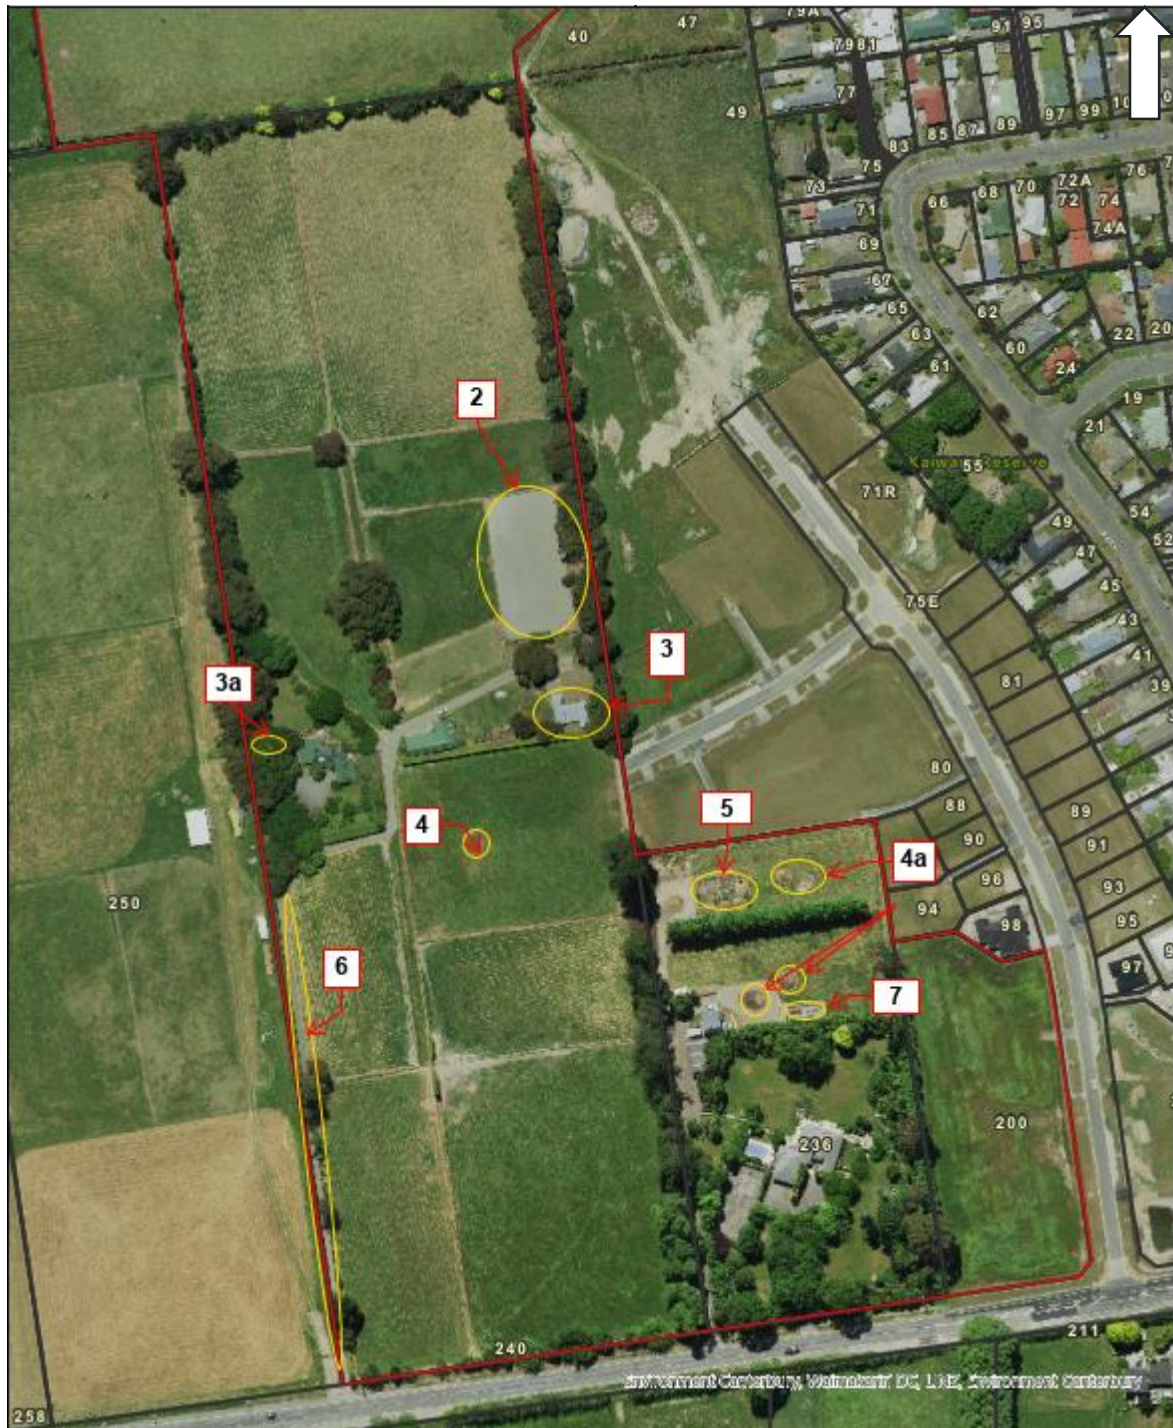
**Figure 9. Locations of Interest at 126 Sparks Road, 17 Northaw Street and 36 Listrella Road (Canterbury Maps, 2023).**

**Figure 10. Locations of Interest at 200, 235 and 240 Cashmere Road (Canterbury Maps, 2023).**

The LOIs are outlined on Figure 9 and Figure 10 and details are provided below with site images attached as Appendix B.

**4 and 4a.** Green waste stockpiles. While the organic material is unlikely to contain any contaminants, any additional items (e.g. timbers and plastics) that may have been placed in these piles could produce contamination if burnt (**HAIL I**). There was evidence during the site walkover that these locations could have previously been used for burning.

- c) **However**, we recommend that the areas outlined as potential HAIL areas undergo additional detailed site investigation (DSI) in terms of the Ministry for the Environments Contaminated Land Management Guidelines to establish the nature, degree, and extent of contaminants distribution.

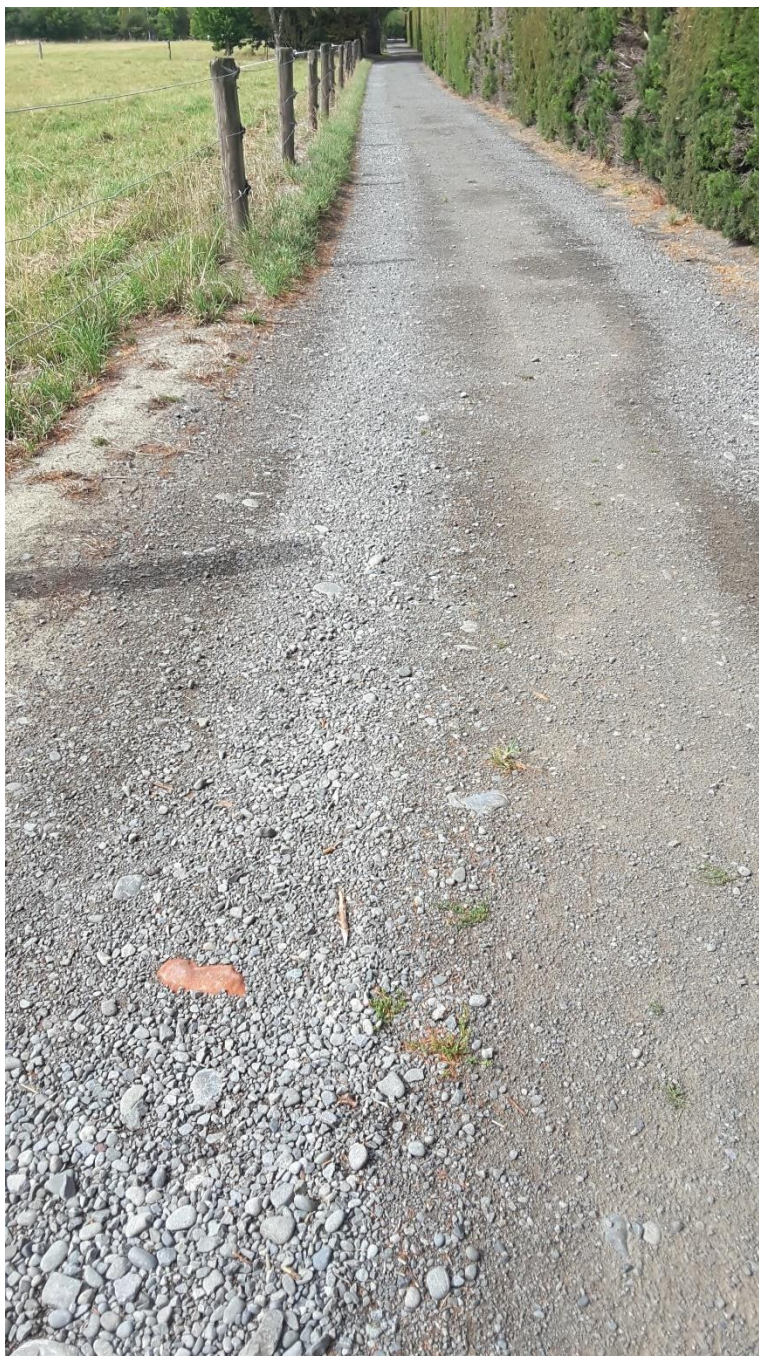
B) Driveway for 240 Cashmere Road that is possibly created with rubble material.

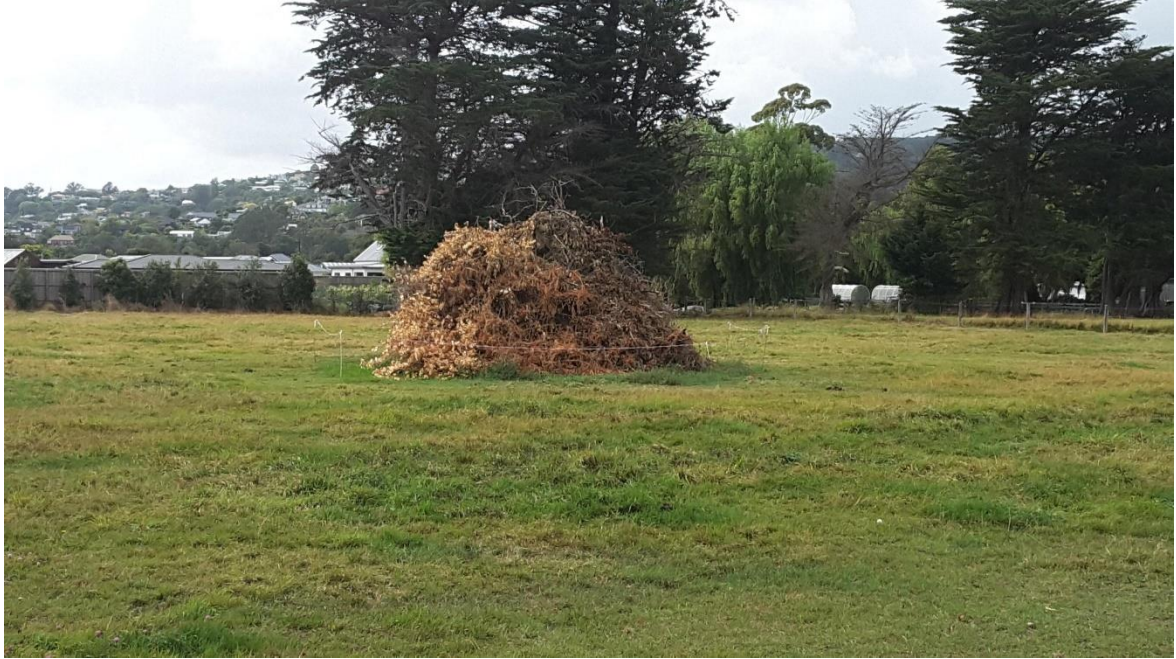
C) Green waste stockpile at 240 Cashmere Road.

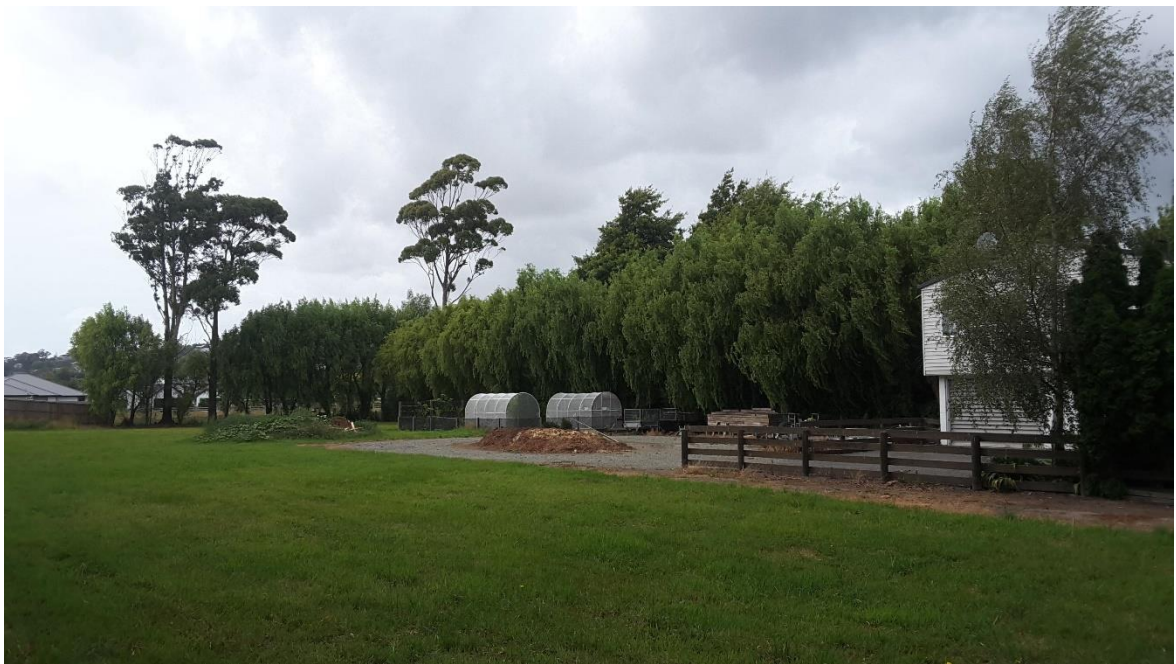
J) Glasshouses and stockpiles at 236A Cashmere Road.

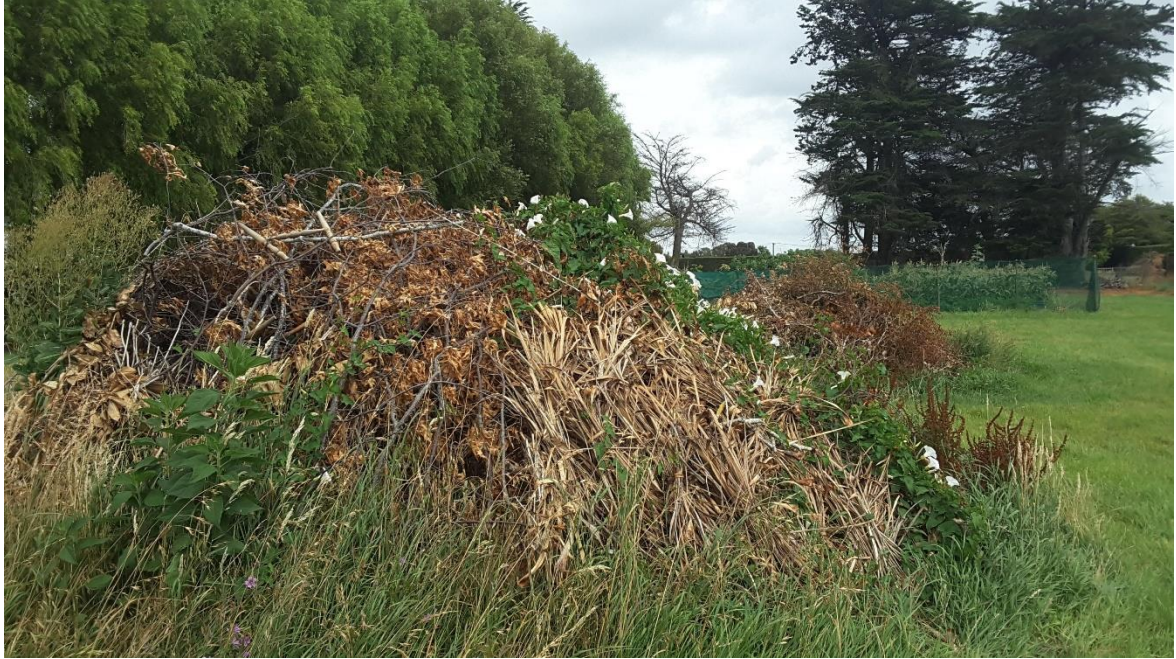
K) Greenwaste stockpiles at 236A with vegetable garden in the background.

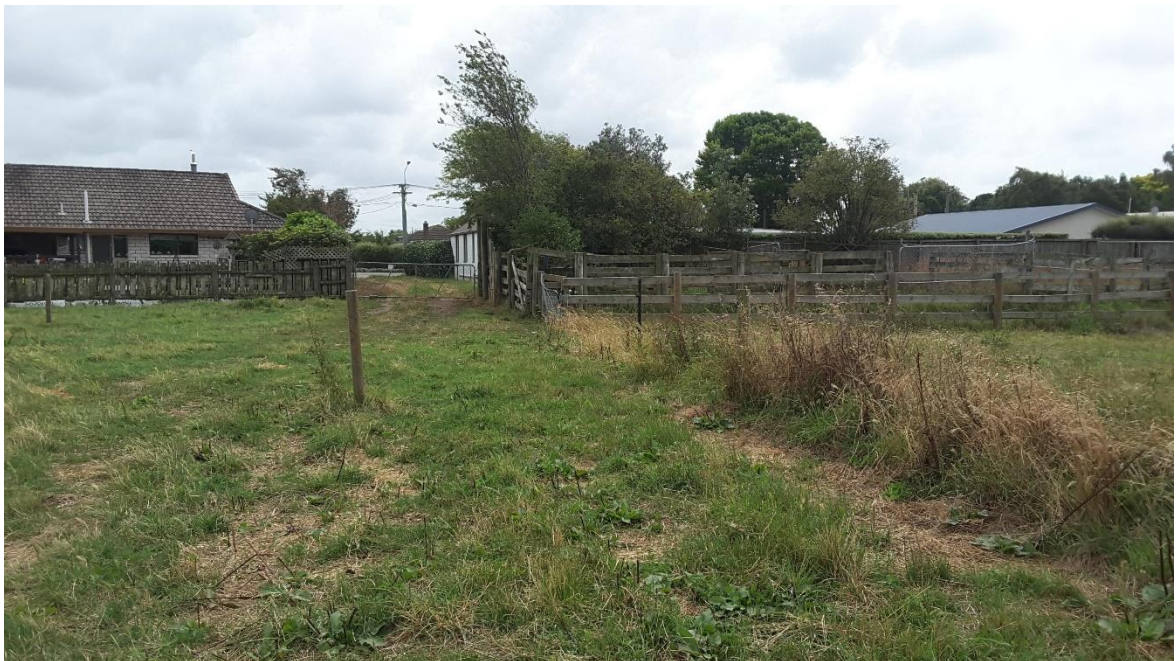
P) The entrance to 126 Sparks Road and the stock pens on 17 Northhaw Street.
