#### 4.3.4 QUARRY MAINTENANCE ENGINEER'S HOUSE: Kennedys Bush Road

# QUARRY MAINTENANCE ENGINEER'S HOUSE

## CURRENT CONDITION & MAINTENANCE REPORT

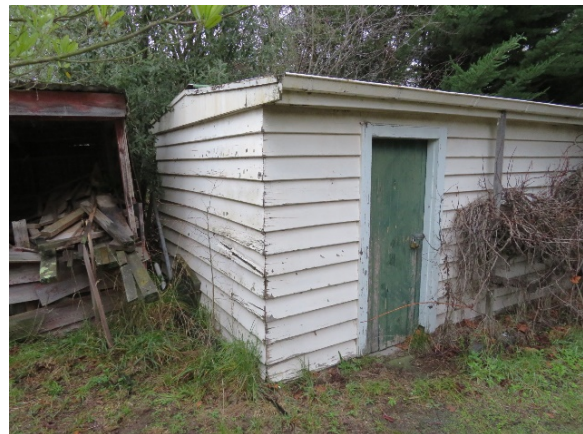
**Figure 137:** Source: T Ussher 06.2021  
*The garage and woodshed.*

The woodshed that is adjacent to the garage shading its east wall is in a dilapidated, partially collapsed state. The northern fence line shed is of adhoc construction using found materials and is in a very poor state of repair

The garage is considered to be repairable, but the woodshed and northern fence line sheds are considered to be beyond repair and it is recommended that they be removed or replaced, although the northern fence line sheds impinge on the outlook and setting of the house.

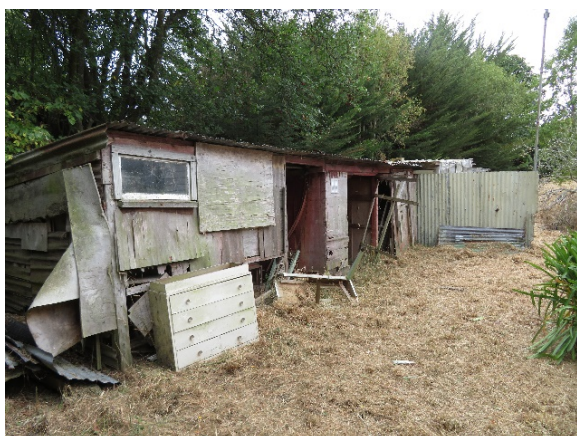
**Figure 138:** Source: T Ussher 01.2020  
*The sheds to the north side of the house.*

and partial collapse. Due to its lack of a proper structure and use of untreated packing crate plywood and demolition materials, the shed is believed to be beyond repair and if retained, would require either significant reconstruction incorporating new fabric or replacement with a new building.

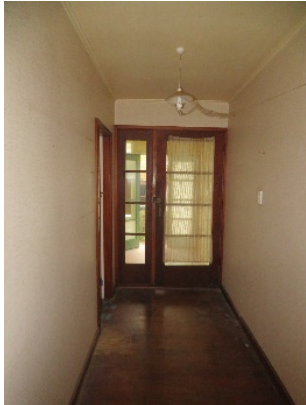
| Item & Photograph | Current Condition and Status Description | Condition Reference | Recommended Remedial Action |
|---|---|---|---|
| <b>Hall</b><br><b>(continued)</b><br> | <p>condition. The ceiling junction is finished with a rimu scotia mould, painted.</p> <p>Skirtings are ex 100x25 rimu bevelled profile, varnished. There is some borer infestation evident.</p> <p>Internal doors and the HWC cupboard doors are framed doors with flush rimu plywood facings with rimu frames and ex45x12 rimu square architraves. Doors are varnished to the hall side.</p> <p>The hot water cylinder and shelving have been removed from the hot water cylinder cupboard.</p> <p>Electrical services. Switches and outlets are recent fabric.</p> | <p>3 Fair</p> <p>3 Fair</p> <p>2 Good</p> | <p>Strip lining paper, repair and re-stop walls and ceilings as required. Hang lining paper and re-paint walls and ceiling.</p> <p>Skirtings will require removal for the replacement of the flooring. Treat borer or replace like-for-like. Reinstall, sand, prepare and re-varnish.</p> <p>Sand, prepare and re-varnish.</p> <p>New HWC installation and shelving reinstatement required.</p> <p>Electrician to inspect the electrical services installation.</p> |

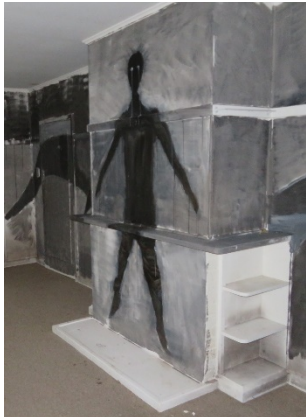
| Item & Photograph | Current Condition and Status Description | Condition Reference | Recommended Remedial Action |
|---|---|---|---|
| | The hall door is a framed door with flush rimu plywood facings with rimu frames and ex45x12 rimu square architraves. It is painted to the living room side but was originally varnished. | 2 Good | Strip paint from the door, frame and architraves, sand, prepare and varnish. |

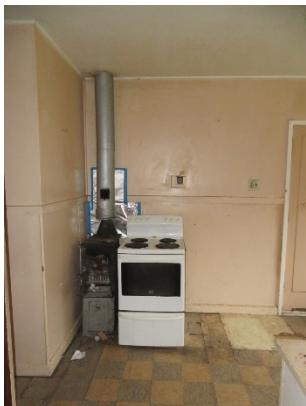
| Item & Photograph | Current Condition and Status Description | Condition Reference | Recommended Remedial Action |
|---|---|---|---|
| | Walls and ceilings are fibrous plaster above painted hardboard wall panelling. All surfaces are worn and there is water damage to the ceiling above the south wall. | 4 Poor | The walls and ceiling linings can be repaired and re-painted but is dependant on whether the kitchen cabinetry is to be replaced with modern joinery. |
