**Quoin Structural Consultants**

12 July 2023

**Harley Chambers, Cambridge Terrace, Christchurch**

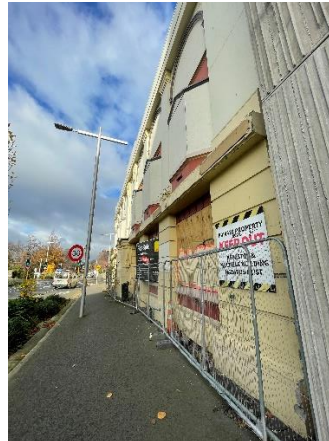
1. The building has suffered some additional damage since my last inspection of the building on 13 December 2016. It is apparent that the building is degrading further over time.
2. The additional damage we observed includes but is not limited to the following:
  - (a) Significant extension and widening of horizontal crack near the base of the north-east column, directly adjacent to the footpath. We know that this column had previously settled and had a crack, but the crack is much wider now and extends all of the way through the column.

Crack appears to be similar to previous 2016 inspection. Quoin notes that the reinforcing of the column section includes widely spaced stirrup reinforcing.

Such horizontal cracks when located between stirrups, which is likely, are considered dangerous and could result in a more sudden-type failure of the column under moderate lateral earthquake loading.

If a **moderate**-large earthquake were to occur in Christchurch (estimate magnitude 6.0 or greater) then this column could fail and cause partial collapse of this corner of the building.

The building itself will not fall over as a whole, but debris could fall out onto the footpath. The suspended floors are well reinforced and perimeter beams tie into the column at each floor level, but the uncertain nature of earthquakes means that we have to expect that some significant damage could occur.

A barricade fence was installed adjacent to this section and is currently in place. However, it is noted that the barricade is located hard up against the building and does not have the suggested 1m minimum gap (see photo below).

It appears that it is not possible to ensure that the barricade is maintained at the recommended safe distance from the building.

At the very least, this column and corner needs to be propped and braced.

Further to our discussion on 18 December 2016, Quoin recommends installation of a barricade on the footpath at least 1m from building and extend it 5m away from the corner. This might link up with barricade at the entry. See (b) below.

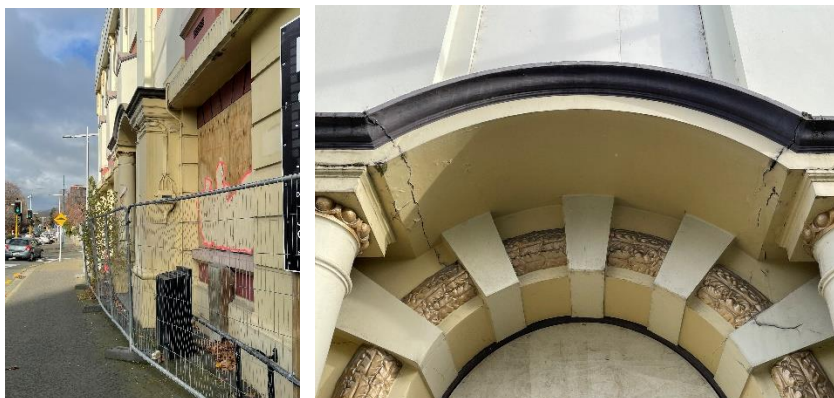
At the top of the joint at parapet level, facing Cambridge Terrace, it appears that there could be some loose concrete. It is difficult to tell without being able to get closer to inspect. This section was cleaned out after a previous earthquake, but given its location and proximity to the footpath then this should be checked again.

We also observed widening of cracks in the front concrete canopy apron over the entry off Cambridge Terrace, which is adjacent to the gap noted above. We do not know exactly how this is constructed so we have to proceed with

caution. The extent of cracking to this section appears to be significantly worse than when inspected in December 2016, which has possibly been caused by ingress of water and the effects of thermal variations over time on the previous cracks. The cracks occur at the mitred corners, so the apron slab may be susceptible to severe damage and possible collapse in a moderate earthquake, depending on the condition of the reinforcing.

A barricade fence was installed adjacent to this section and is currently in place. However, it is noted that the barricade is located hard up against the building and does not have the suggested 1m minimum gap (see photo below). It appears that it is not possible to ensure that the barricade is maintained at the recommended safe distance from the building, likely because the location of such barricade impacts greatly on the width of the public footpath.

This means that if any part of the canopy apron were to spall, or collapse under a moderate earthquake, then the barricade may not prevent serious injury to the passing public.

Quoin recommends providing temporary fences/barricade approximately 1m away from building to provide safety from any falling debris. The apron is not too high above footpath so 1m should be adequate. Further investigation can be undertaken in due course if required.

Quoin recommends immediate reinstatement of the barricade fence at 1m distance from the front face, or demolition of the apron canopy, or installation of temporary propping beneath the canopy.

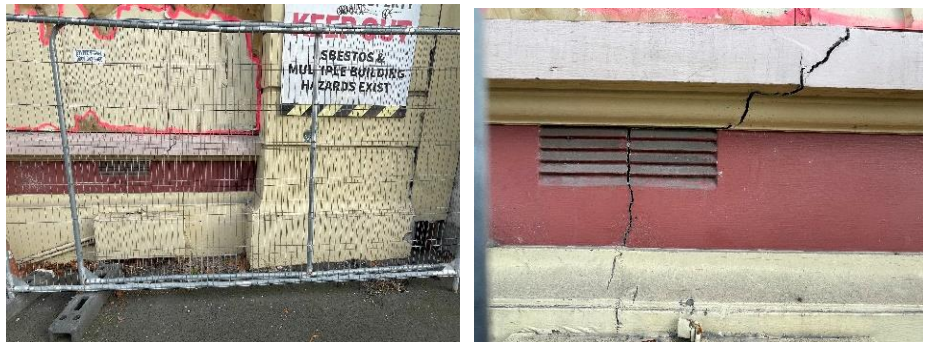
- (c) The cracks at the base of the parapet are more visible than they used to be. The parapets that face onto Cambridge Terrace and Worcester Boulevard comprise of reinforced concrete. It is our opinion that they are safe.
- (d) There appears to be a number of new cracks in the front facade to Cambridge Terrace and Worcester Boulevard (plaster over concrete structure), or maybe older cracks that have widened and/or extended. Since our last inspection, these are worsening such that ongoing degradation from wind and rain could cause spalling of the plaster/concrete. We note that this is directly adjacent to the footpath and worst along Cambridge Terrace.

The very wide cracks in the east facade beneath the northern-most lowest window, adjacent to the north-east column noted in (a) above, appear to have

widened slightly since 2016. This suggests possible ongoing settlement of the corner column. It is noted that the basement at this same corner of the building remains full of water.

With the basement being full of stagnant water for long periods of time, and having been through numerous attempts to dewater, plus the settlement that has occurred and that appears to be ongoing, there is likely to be added degradation to the structure that includes but may not be limited to:

- i. More extensive contamination of the concrete to the basement walls and base slab.
- ii. Added degradation of the reinforcing, typically at the crack locations.
- iii. Added stresses in the corner column and adjacent beams, over the height of the building, as caused by the settlement. Such cumulative added stresses reduce the residual strength of the affected column and adjacent beams.

A barricade may be required at some stage. As noted above, a barricade is in place, albeit hard up against the building and not 1m away from the building as is the suggested minimum distance should small debris fall from the building.

Quoin recommends a closer inspection be completed to assess if any material is loose and this should include the close inspection noted in (b) above.

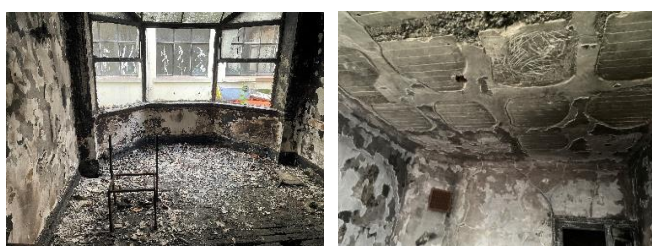
- (e) A fire occurred in the south-west corner of the north section of the building at ground level.

The ceiling has been burnt out and it appears that the soffit of the concrete floor above was exposed to the fire.

Also, extensive spalling occurred to the plaster finishes of the internal breeze block wall.

This has likely resulted in a reduction in loadbearing capacity of the floor in this localised area.

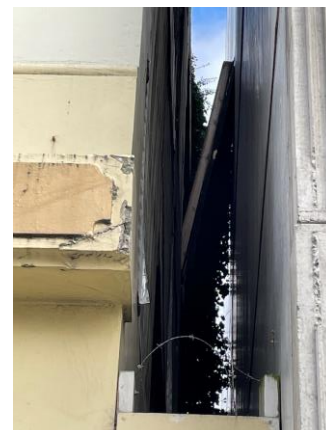
- (f) Temporary timber infill to a north side window appears to have fallen out towards the adjacent building at 141 Cambridge Terrace.
