**IN THE MATTER** of Resource Consent applications CRC242267,  
CRC242268, CRC242269, CRC242269 and  
RMA/2023/3243 by Christchurch City Council (**the  
Applicant**) for Southshore and South New Brighton Park  
Estuary Edge Project

**STATEMENT OF EVIDENCE OF THOMAS GEOFFREY PARSONS  
ON BEHALF OF CHRISTCHURCH CITY COUNCIL  
(PROJECT BACKGROUND)  
Dated: 20 November 2025**

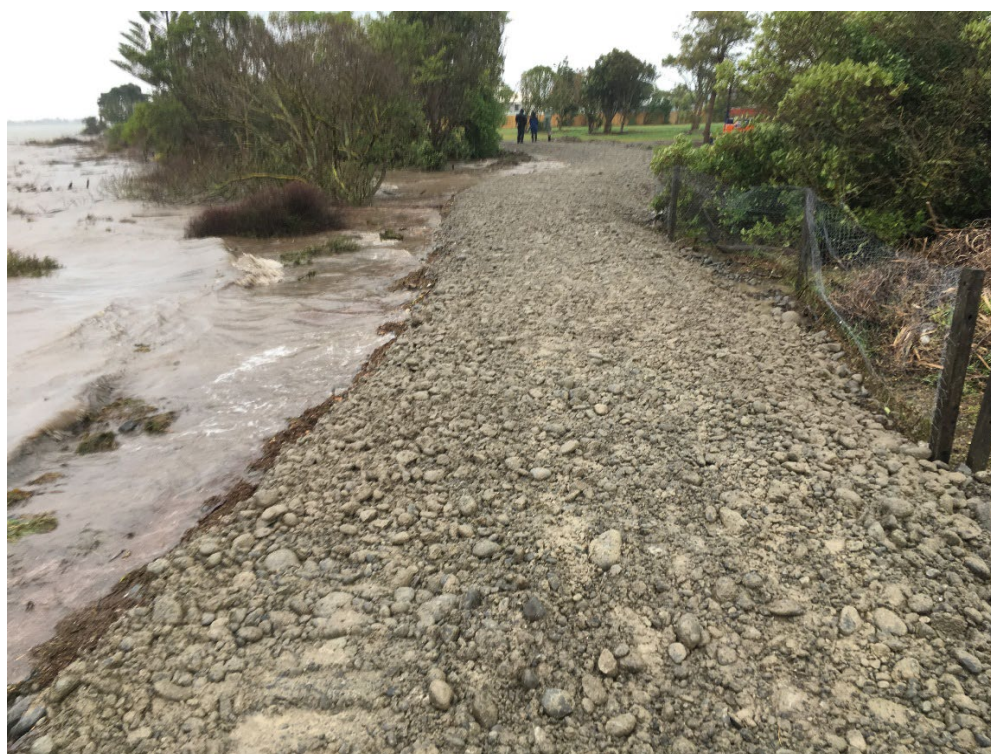
- (b) *In response to the tidal flooding of 21 July 2017 emergency works were constructed that aimed to significantly reduce the extent of the flooding predicted to occur on the following tide (22 July 2017). The following low points were filled along Southshore (Figure 3):*
  - (i) *Council owned roads (heads of cul-de-sacs) at Penguin Street, Heron Street and Tern Street*
  - (ii) *Over privately owned land at 44A and 78 Rocking Horse Road*
  - (iii) *Through South New Brighton Park in the vicinity of the Estuary Road RRZ*

**Figure 3 Emergency Works Near to Penguin Street during Event of 22 July 2017**

9.3 Council resolved at the hearing of the report to stabilise the emergency works. In parallel staff worked to gain retrospective consent for the emergency works, which was subsequently granted by the Canterbury Regional Council. These works included making the flood defences more robust, strengthening erosion protection structures at Southshore Road ends and about 44A Rockinghorse Road, and installation of temporary pumping access points, which aimed to facilitate installation of temporary pumps to manage surface flooding during storm events.

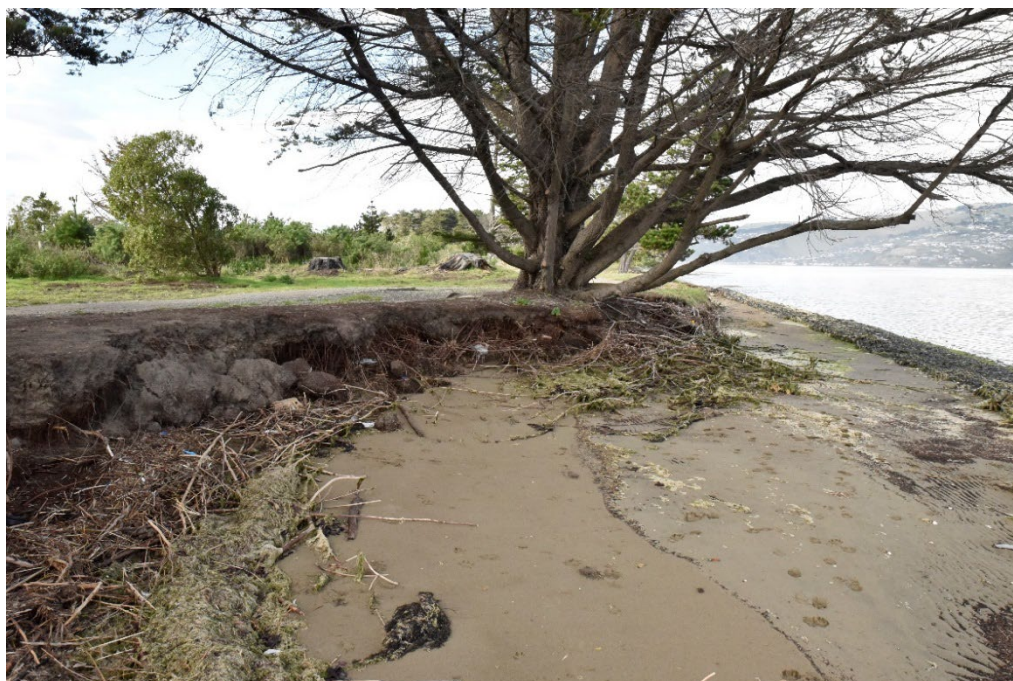
- (c) *The purpose of the emergency works was not to address erosion of the Estuary edge within South New Brighton Park (Figure 5). Prior to the earthquakes attempts had been made to manage erosion of the Estuary edge using engineered coastal defences (reno mattresses). These defences failed in some areas during the earthquakes through slumping or lateral spreading. This lowered the top of the mattresses and exposed the bank in areas below high tide level to wave action.*

*Landward migration of the top of bank is now occurring with some tree loss and the formation of beaches behind the mattresses...*

**Figure 5 Estuary Edge Erosion within South New Brighton Park**

- 8.7 In 2020 the Crown transferred of ownership to the Council. This ended LINZ management of the area.
- 8.8 Away from the RRZ there was damage to Council owned assets through South New Brighton Park. The edge protection assets were severely damaged and dropped in height, resulting in overtopping by waves and erosion of land. Existing trees began to decline, resulting in tree removals and relocation of recreational pathways along the edge.
