### Table 1 | Current Resource Consents

Scope of resource consent CRC193248

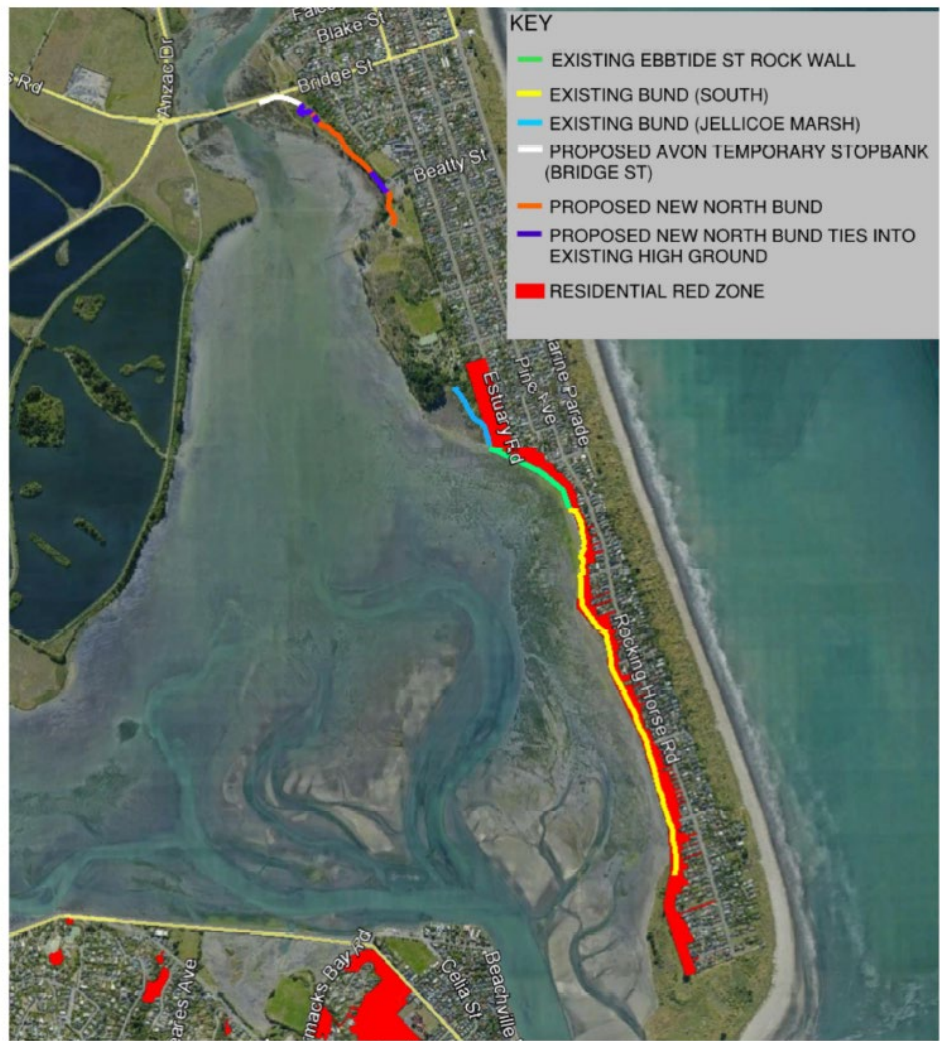
Figure 2 - Bund overview plan (Image source: Google Earth)

CRC193248 authorises a range of emergency works, originally carried out in 2016/2017 in response to repair works to the existing landscape feature, construction of a flood risk reduction bund along Jellicoe Marsh and a small portion (approximately 50 m) of erosion protection structure along the edge of the estuary within the CMA.

- Works to the bund around Jellicoe Marsh including a new bund being constructed
- Infill / repairs to the landscape bund
- Erosion protection in the CMA at the end of Heron Street and adjacent to 44 A Rocking Horse Road (approximately 25 m in each location).

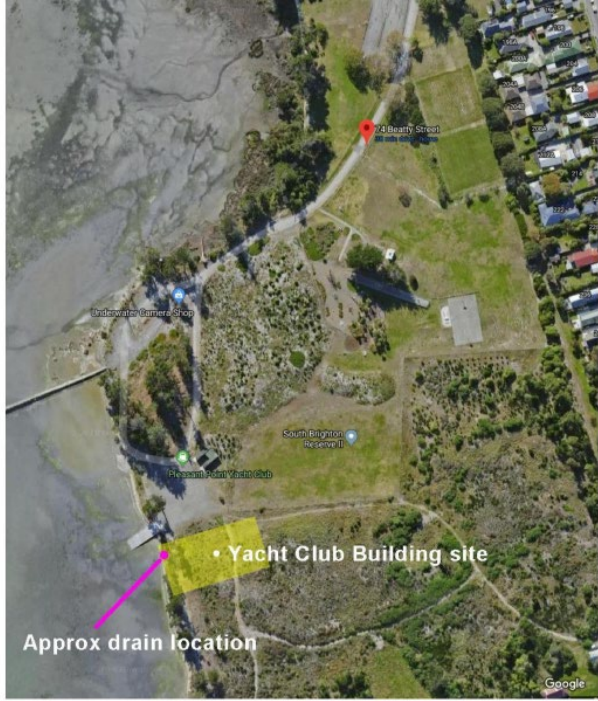
| Consent Reference | Description of structure | Drawing Reference | Snip of location | Comment |
|---|---|---|---|---|
| CRC191613 | Stormwater outfall including scour protection | General Arrangement Sheet 1 | | <p>A small, localised area where scour protection has been installed to reduce erosion risk associated with a stormwater outfall pipe.</p> <p>The outfall is not shown on the project drawings.</p> |

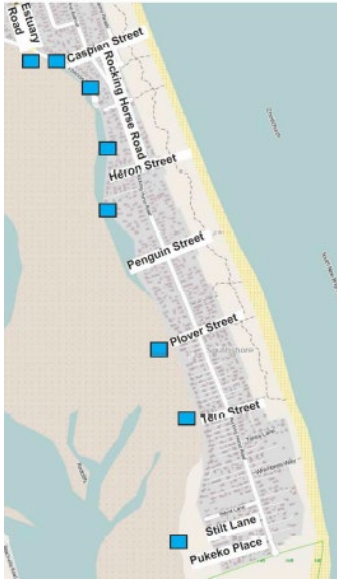
| Consent Reference | Description of structure | Drawing Reference | Snip of location | Comment |
|---|---|---|---|---|
| CRC145555 | Repairs to stormwater outfalls located between Estuary Road and Silt Lane (15 in total, 8 identified as needing repair) | General Arrangement Drawings 3 to 7 inclusive. | | <p>This relates to repair works to a number of stormwater outfalls located along South New Brighton and Southshore.</p> <p>Works relating to protection of outfall discharge points, in reasonable proximity to the outfall structures, are assessed as consented.</p> |

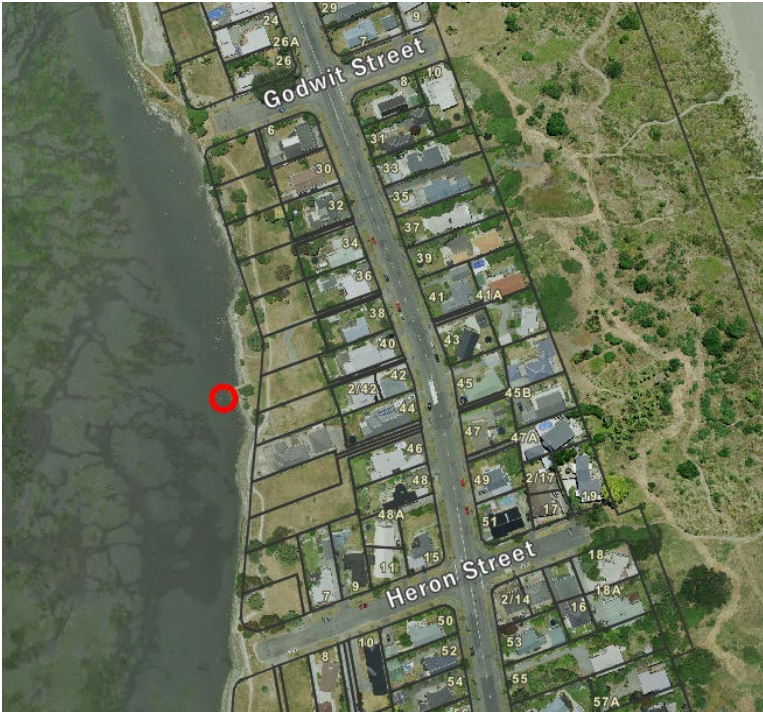
| CRC981649 | Disturb CMA, deposit sand / gravel and replant foreshore for protection of residential properties | General Arrangement Sheet 3 and 4 | | <p>No information is publicly available via ECan’s database.</p> <p>This consent allows for foreshore disturbance, deposition of material in the CMA up to 1,700 m³, replanting and construction of an informal pathway located at or near Mean High Water Springs to facilitate access.</p> <p>The location of map reference NZMS 260 M35:892-406 puts this work at an approximate location of works between Godwit Street and Heron Street.</p> <p>Of note, the purpose of the consent relates to the protection of residential properties.</p> |
