In the matter of Plan Change 18 (Hendersons Residential Rezoning) to the  
Christchurch District Plan

**Cashmere Fields**

**Evidence of Nicholas John Traylen**

14 August 2026

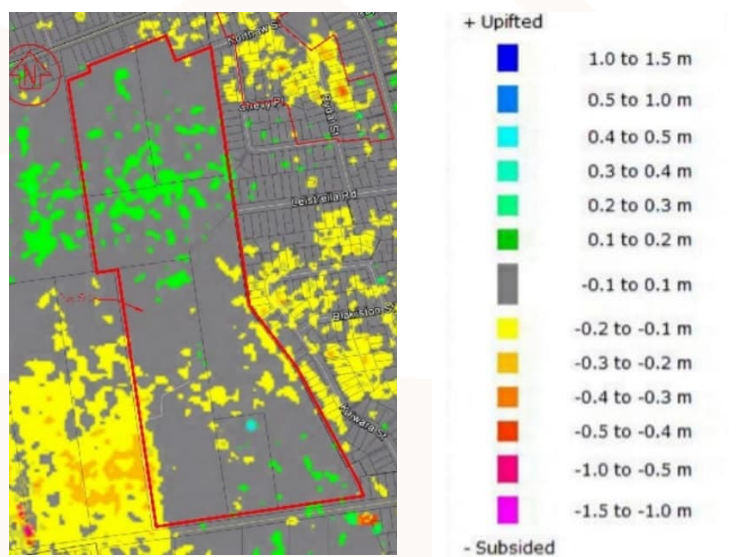
Figure 1 Lidar ground deformations, September 2010 to June 2011 Events

Lidar data shows very little to only moderate cumulative ground deformations at the site from the events spanning from September 2010 to June 2011. Appendix 1 (figure SK2) shows the results of these damage observations.

All the land to the immediate east of the site is classified as MBIE Technical category 2 (“TC2”); the Lidar cumulative ground deformations there (i.e. to the immediate east) are similar, if not slightly more intense, than those on this site. Our own observations on the site following the February 2011 earthquake event showed only minor surface manifestation of liquefaction, affecting less than 5% of the land (See Appendix 1).

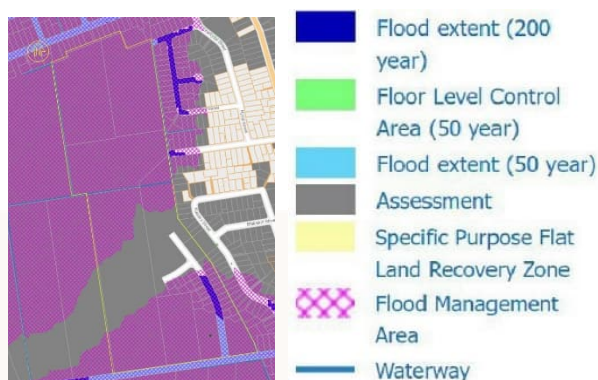
Figure 3 CCC Flood Map

<https://www.ccc.govt.nz/services/stormwater-and-drainage/flooding/floorlevelmap> were accessed on 15 June 2023. The CCC system shows that much of the site, with the exception of some higher ground in the central portion of the land, is within the modelled 50-year and 200-year flood extents, and is within the Flood Management Area (“FMA”). The City Council should be referred to for further information.

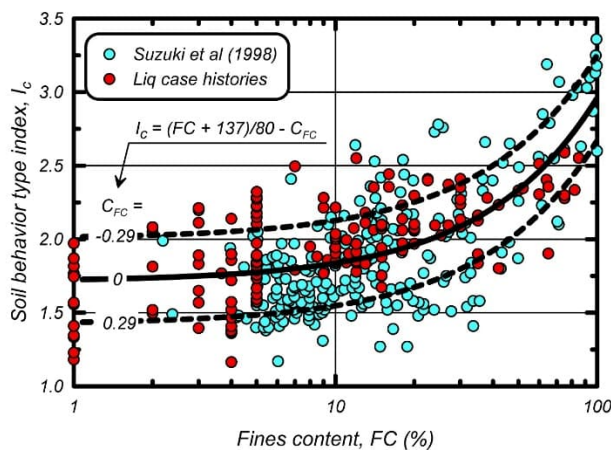
Figure 4 - Figure 2.11 from Boulanger & Idriss (2014)

For routine liquefaction analysis it is common to use soil fines contents ('FC') that are inferred from the CPT data, rather than actual FC data from laboratory testing. This can affect the outcome of the analysis to varying degrees. The more robust way to carry out an analysis is to use detailed laboratory-measured fines contents from actual soil samples. However, the cost of doing this can be relatively high, and often not warranted on small projects. The CPT data-derived fines content formulation uses a 'best fit' line from a regression of historical FC and  $I_c$  data ( $I_c$  is a parameter derived from CPT data) – see Figure 4 below.

The data is however quite scattered, and a particular site might not necessarily be best represented by the 'best fit' line ( $C_{FC} = 0$  in Figure 2). In Christchurch it is not uncommon for site data to fall well below the best fit line, for example. Other correlations can be used by employing an appropriate site-specific 'fines correction factor' (" $C_{FC}$ "). It is often found in Christchurch that a  $C_{FC}$  of 0.2 – 0.3 can be appropriate.

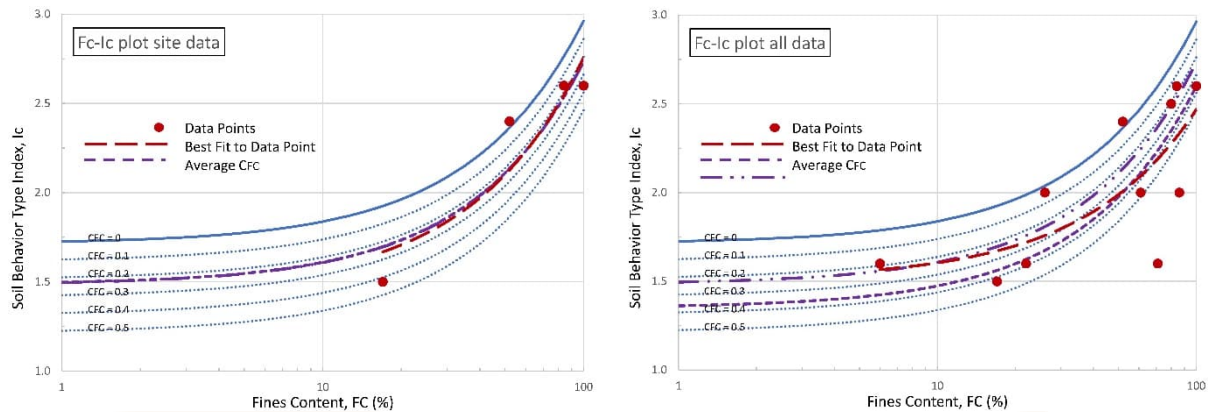
Figure 5 –  $C_{FC}$  Plots

Four samples were retrieved from the liquefiable soils at the Cashmere Fields site and tested for fines content, as part of a silty soils research project in 2013. The fines content tests when regressed against the CPT-derived  $I_c$  parameter, showed that a  $C_{FC}$  parameter of 0.23 is appropriate. (When additional data is added from adjacent properties, the average  $C_{FC}$  is even higher.)

(a) site specific data only.

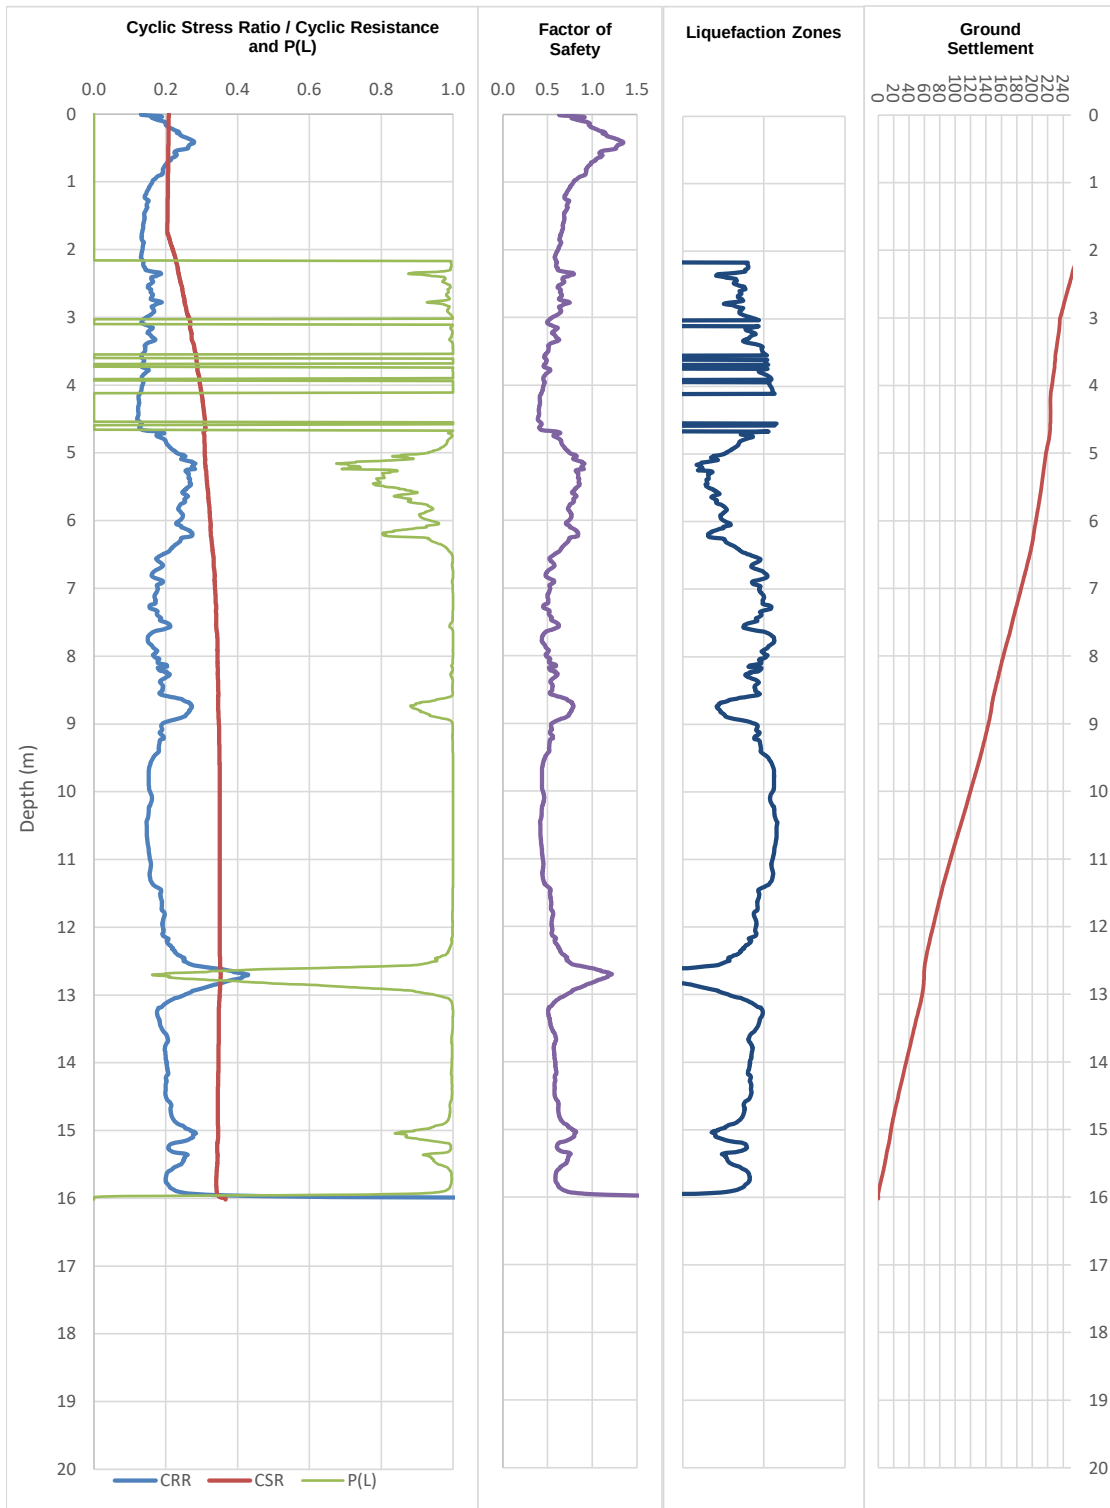
Based on Idriss & Boulanger (2014) and Zhang (2002)

$a(g) = 0.35$

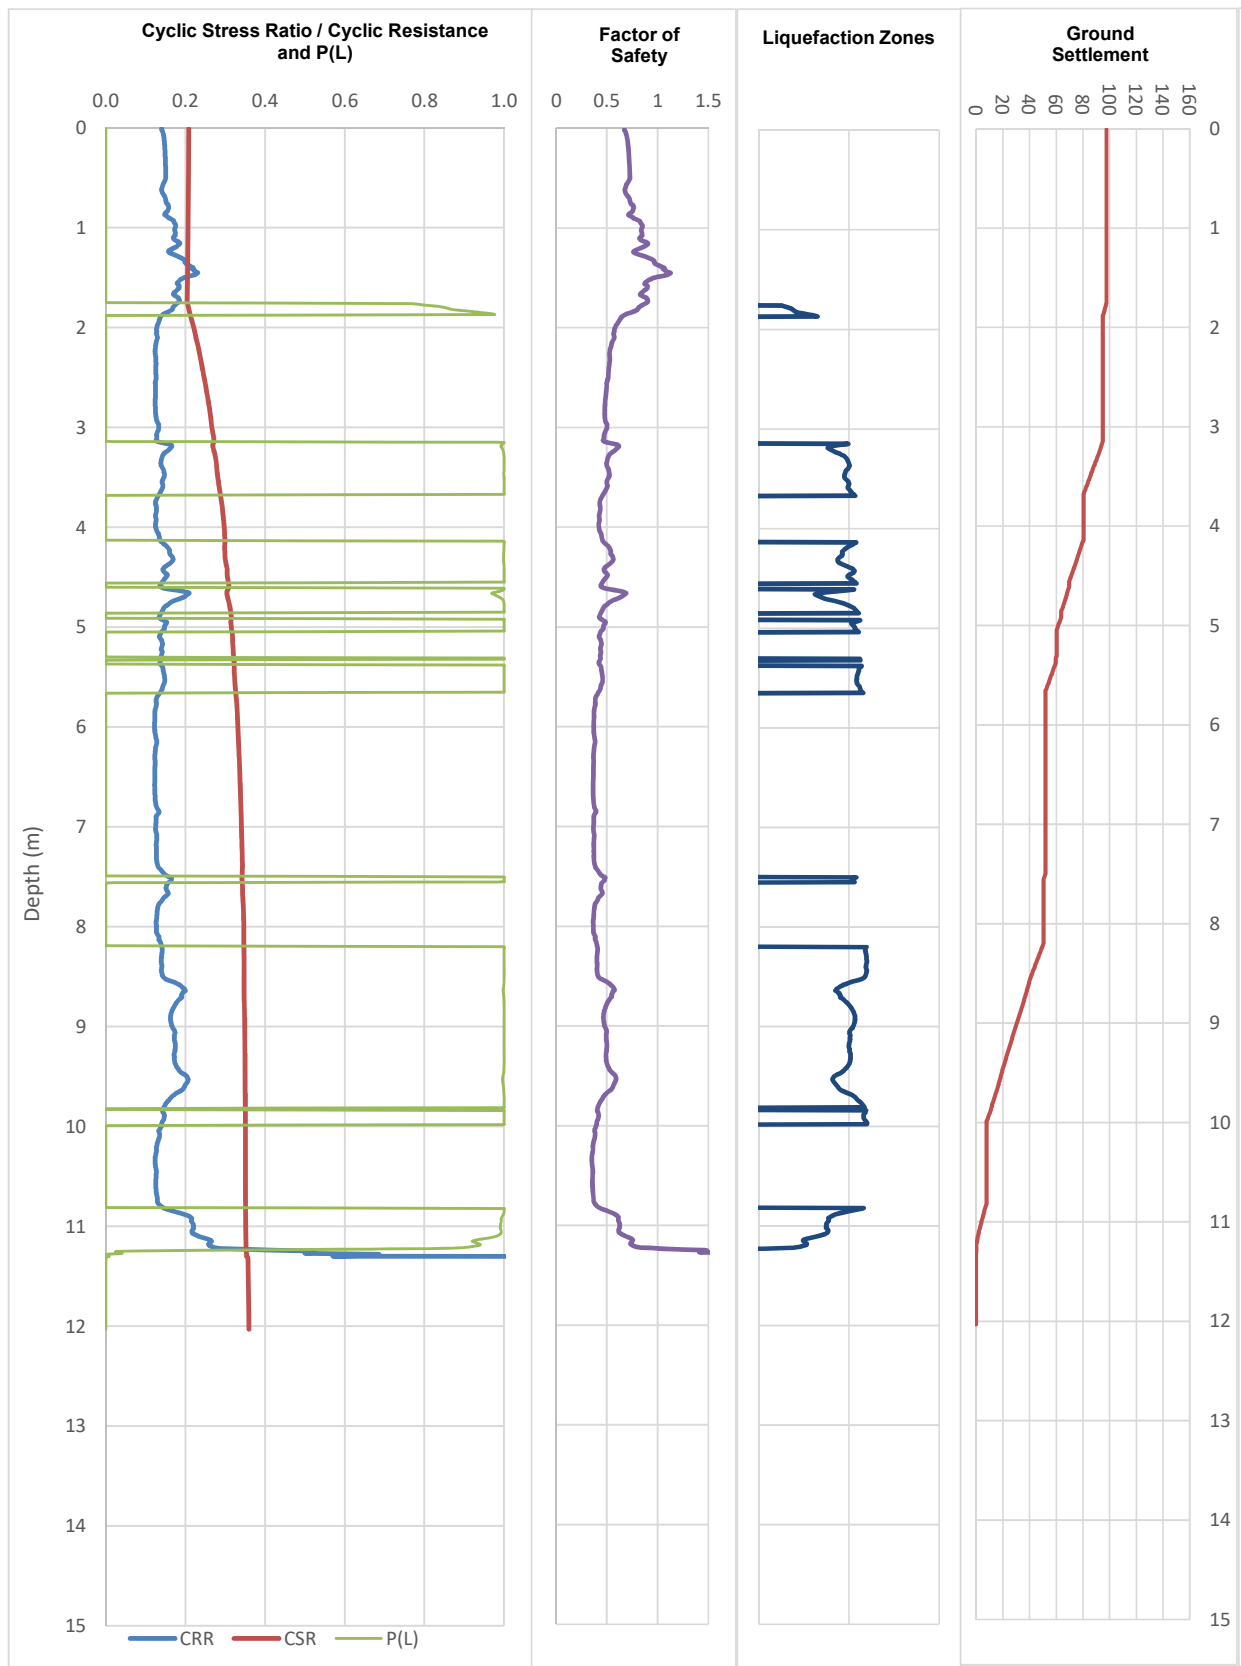
| Based on Idriss & Boulanger (2014) and Zhang (2002) | <b>ULS 1 in 500 yr</b><br>$a(g) = 0.35$ $M 7.5$ |
