# Geotechnical Investigation Report

Hornby Quadrant Stage 5

Calder Stewart Land Holdings Limited

Document Number: 220748-RPT-G-001-A

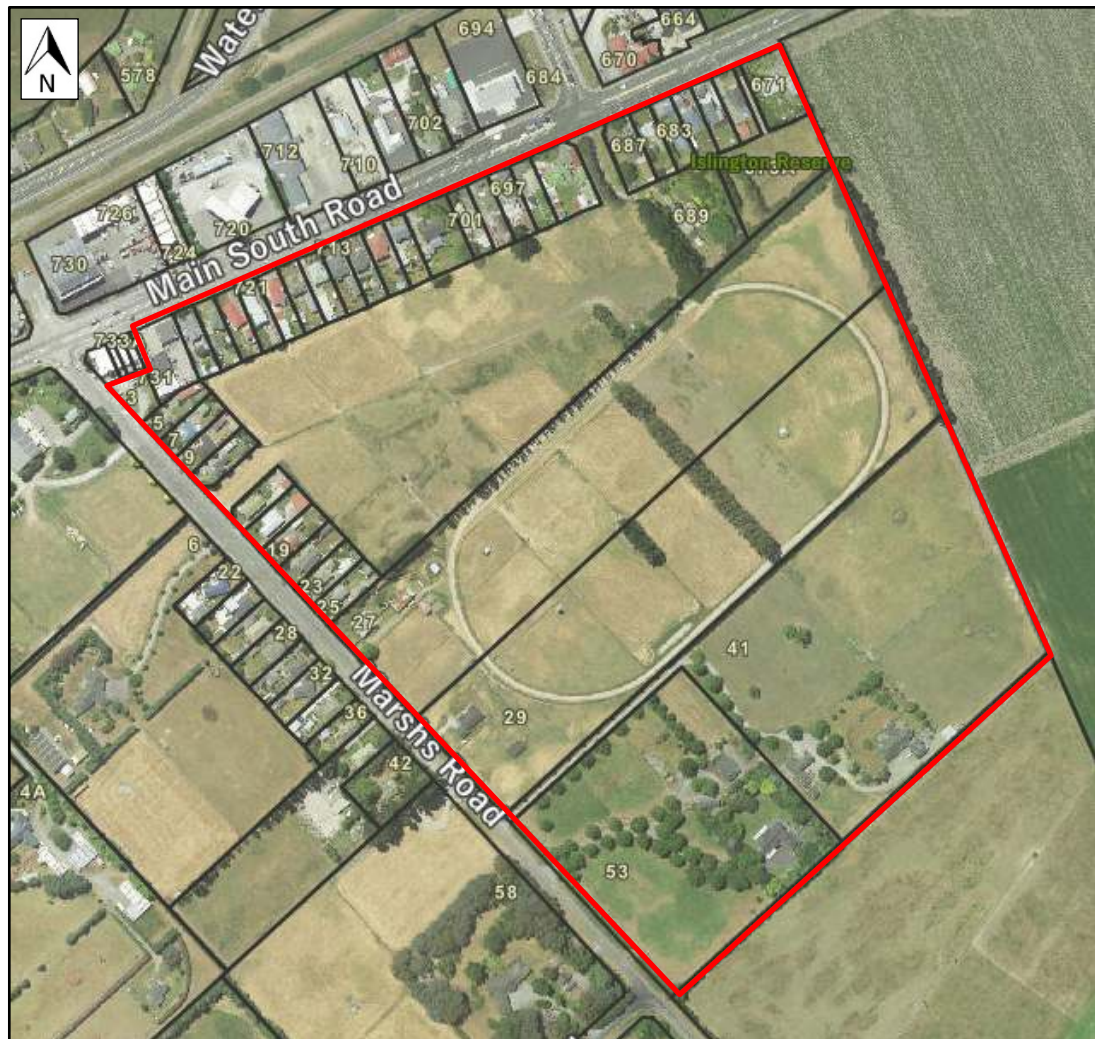
**Figure 1:** The existing site layout, with approximate boundaries shown in red. Image taken from Canterbury Maps, accessed 18/10/22.

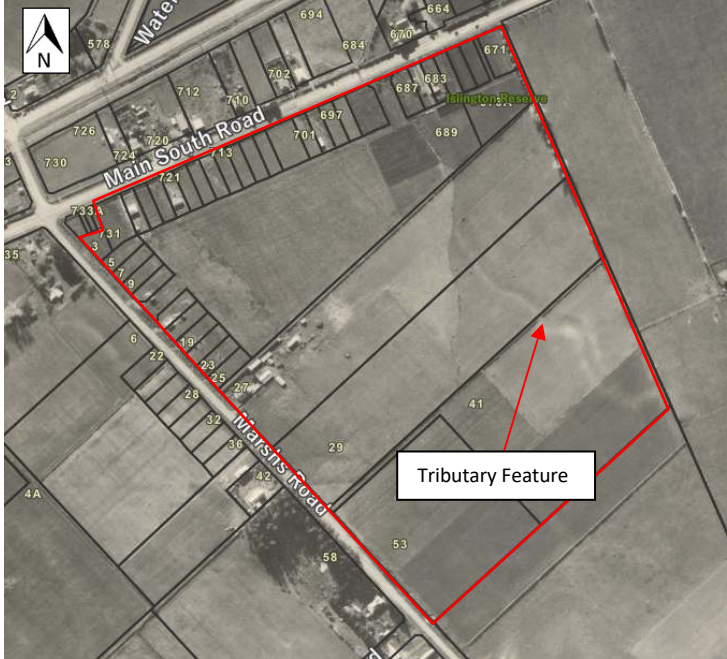
| Aerial Photograph | Description |
|---|---|
| | <p>Canterbury Maps 1955-1959.</p> <p>The majority of site is farmland. Some residential properties on Marshs Road and Main South Road have been constructed.</p> <p>A shallow and dry tributary feature can be seen within the eastern margin of site.</p> |

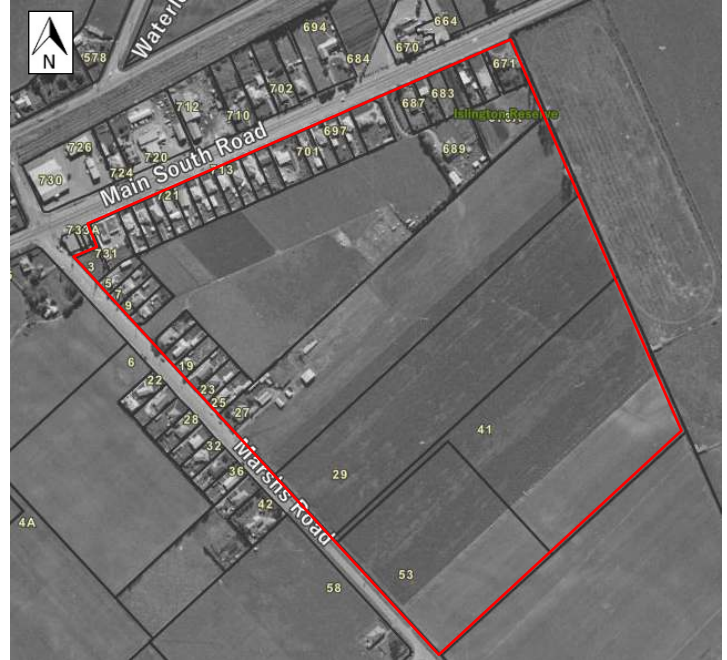
| Aerial Photograph | Description |
|---|---|
| | <p>Canterbury Maps 1970 - 1974.</p> <p>The majority of residential dwellings along Marshs Road and Main South Road have been constructed.</p> <p>The tributary feature appears to be less prominent on the landscape.</p> |
