#### 4.3.4 QUARRY MAINTENANCE ENGINEER'S HOUSE: Kennedys Bush Road

# QUARRY MAINTENANCE ENGINEER'S HOUSE

## CURRENT CONDITION & MAINTENANCE REPORT

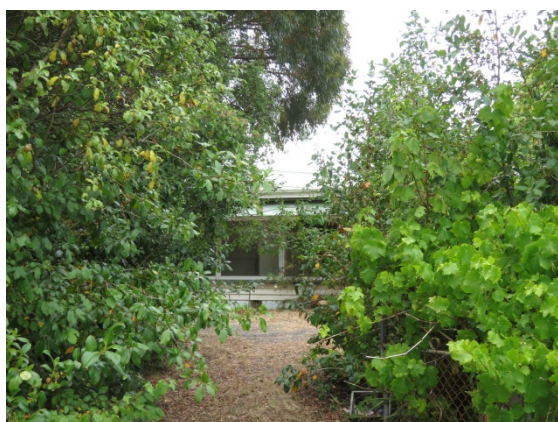
**Figure 130:** Source: T Ussher 01.2020

*A glimpse of the house is possible from the Kennedys Bush Road entrance due to overgrown planting.*

The garden is overgrown and requires maintenance including cutting back of foliage from the house. There is a single garage built at the same time as the house that is in poor, but salvageable repair that is also overgrown requiring clearance of foliage. Two shed structures on the property are of ad-hoc construction using salvaged materials to hand and are considered to be beyond repair.

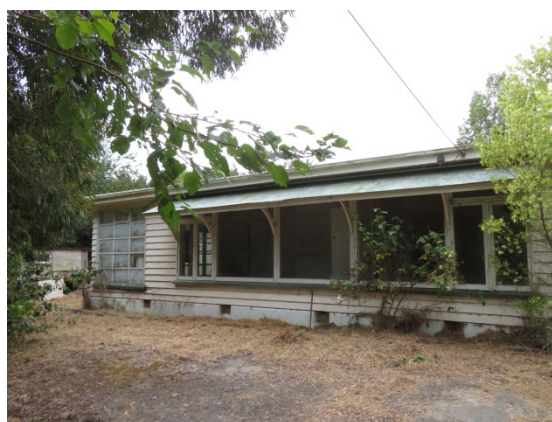
**Figure 131:** Source: T Ussher 01.2020

*The west, road-side façade of the house.*

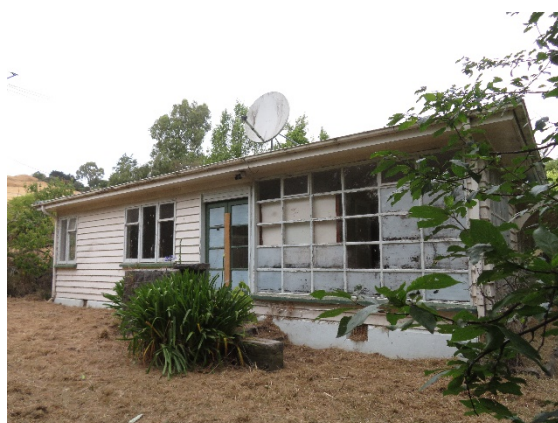
**Figure 132:** Source: T Ussher 01.2020

*The north façade of the house with the glazed lattice window to the sunporch.*

The sunporch is partially enclosed with the large trellis pattern timber windows with fixed panes. Generally, the windows need re-puttying of the glass panes throughout, and re-painting. The sill and lower jambs of the west side window panel have rotted out and the window panel will require removal, repair and reconstruction.

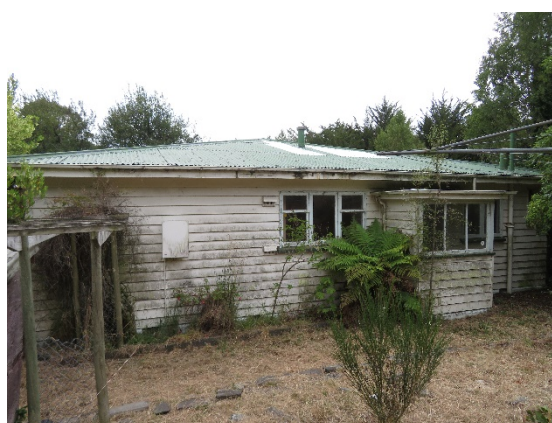
**Figure 133:** Source: T Ussher 01.2020

*The south side of the house with the rear porch.*

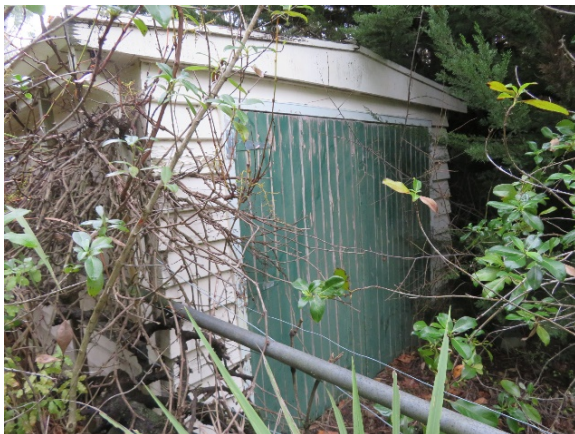
**Figure 136:** Source: T Ussher 06.2021  
*The street frontage of the garage.*

The house is provided with a single garage, the weatherboard cladding of which is in poor repair where trees and planting against the walls have caused the cladding to rot. A substantial vine growing against the north wall is also causing deterioration of the weatherboards. The roof is corrugated iron with timber barge boards and cappings that are in poor repair due to overhanging trees and lack of maintenance. The spouting and downpipes are badly rusted and downpipes are disconnected contributing to the rotting of the wall cladding.
