# Application for Resource Consent: Land Use

**Re: 2 Gosset Street, St Albans, Christchurch  
Detailed Earthquake Damage Assessment and Repair Strategy Report for the Existing  
Dwelling and Detached Garage**

New Houses  
 2 Gosset Street  
 and  
 25 Westminster Street

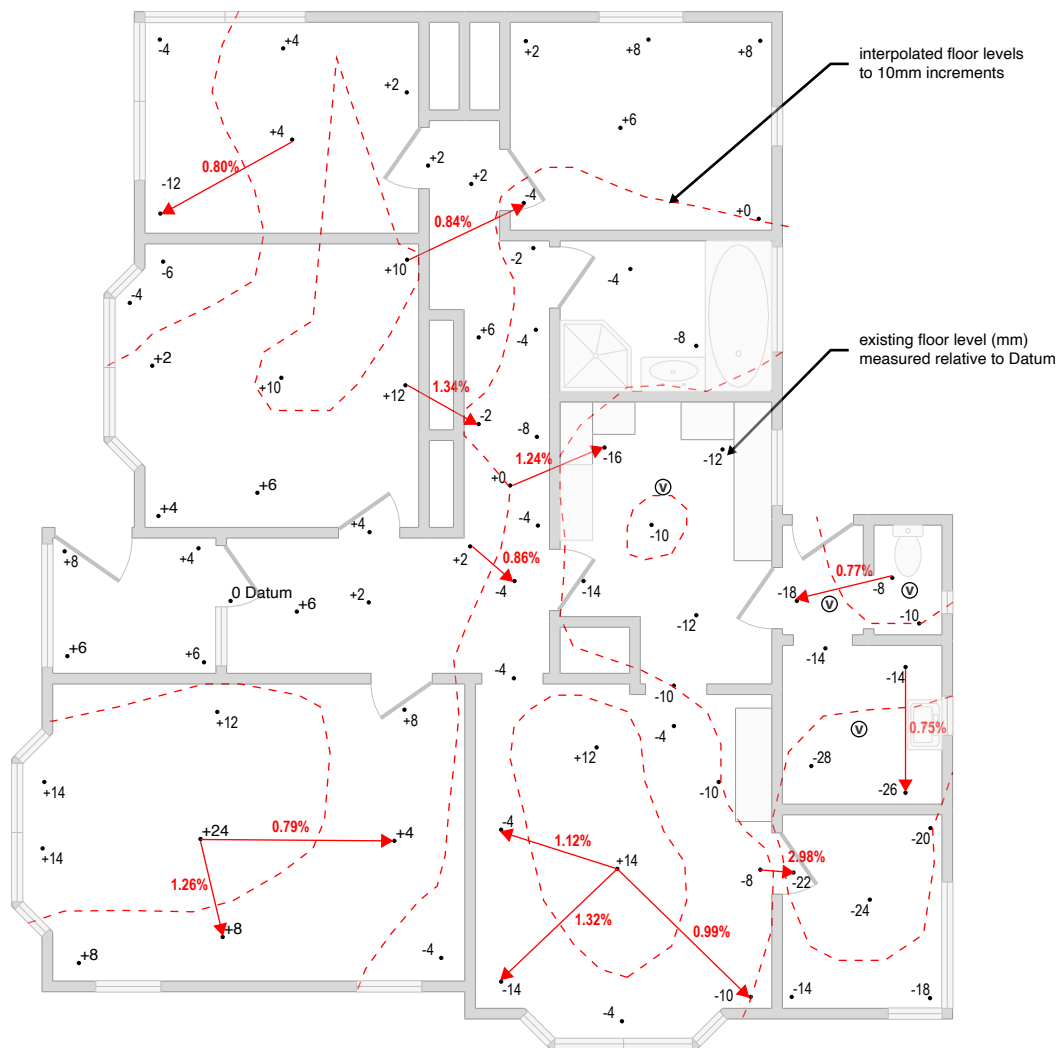
| Drawing Ref: <b>S1-0</b> | Revision: - |

### Damage Assessment & Site Survey by Grounded

| <span style="color: red;">→</span> 0.79% | localised floor slope (%) |

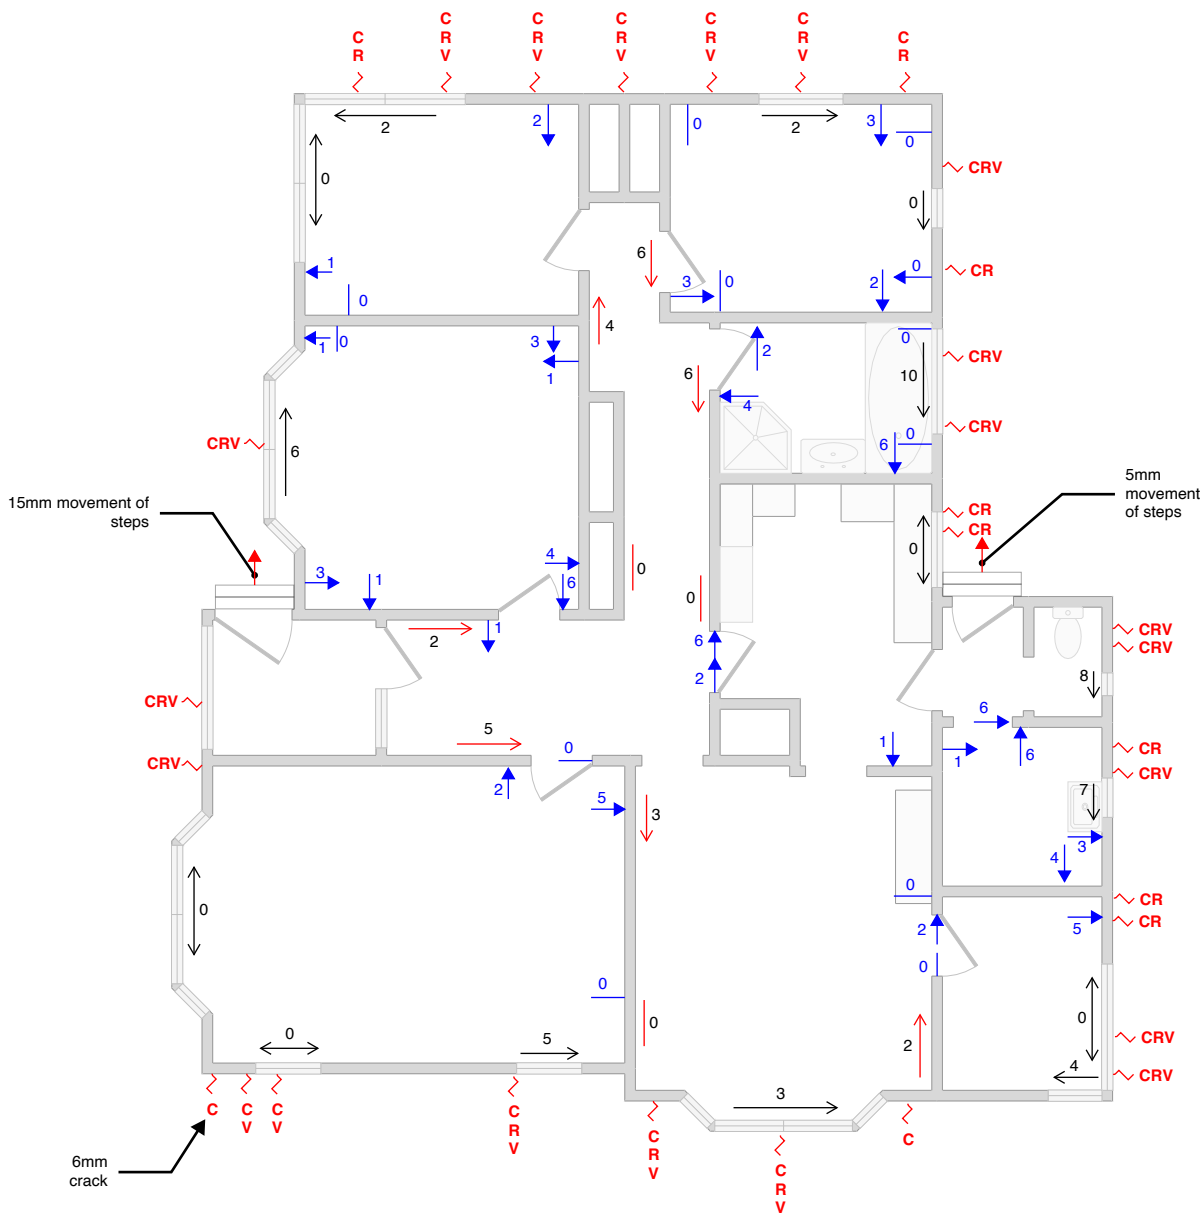
| Drawing Ref: <b>S1-1</b> | Revision: - |

- = sill slope (mm/m)
- = wall verticality (mm/m)
- = picture frame slope (mm/m)
- ~ C = crack in external face of foundation
- ~ R = signs of repair
- ~ V = foundation vent

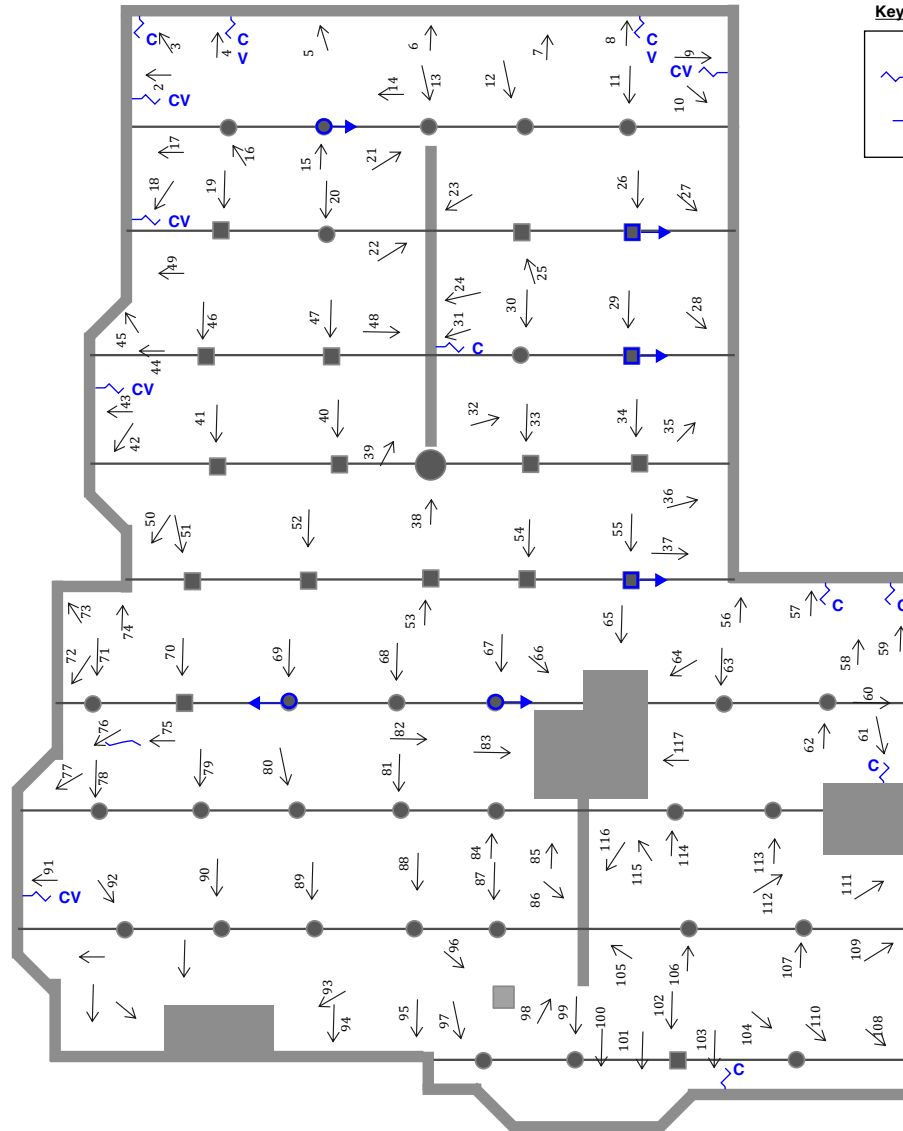
- Round precast concrete pile.
- Square precast concrete pile.
- Jerry can pile.
- Brick prop.

- C = crack in internal face of perimeter foundation
- V = crack located at the vent
- = direction of leaning pile

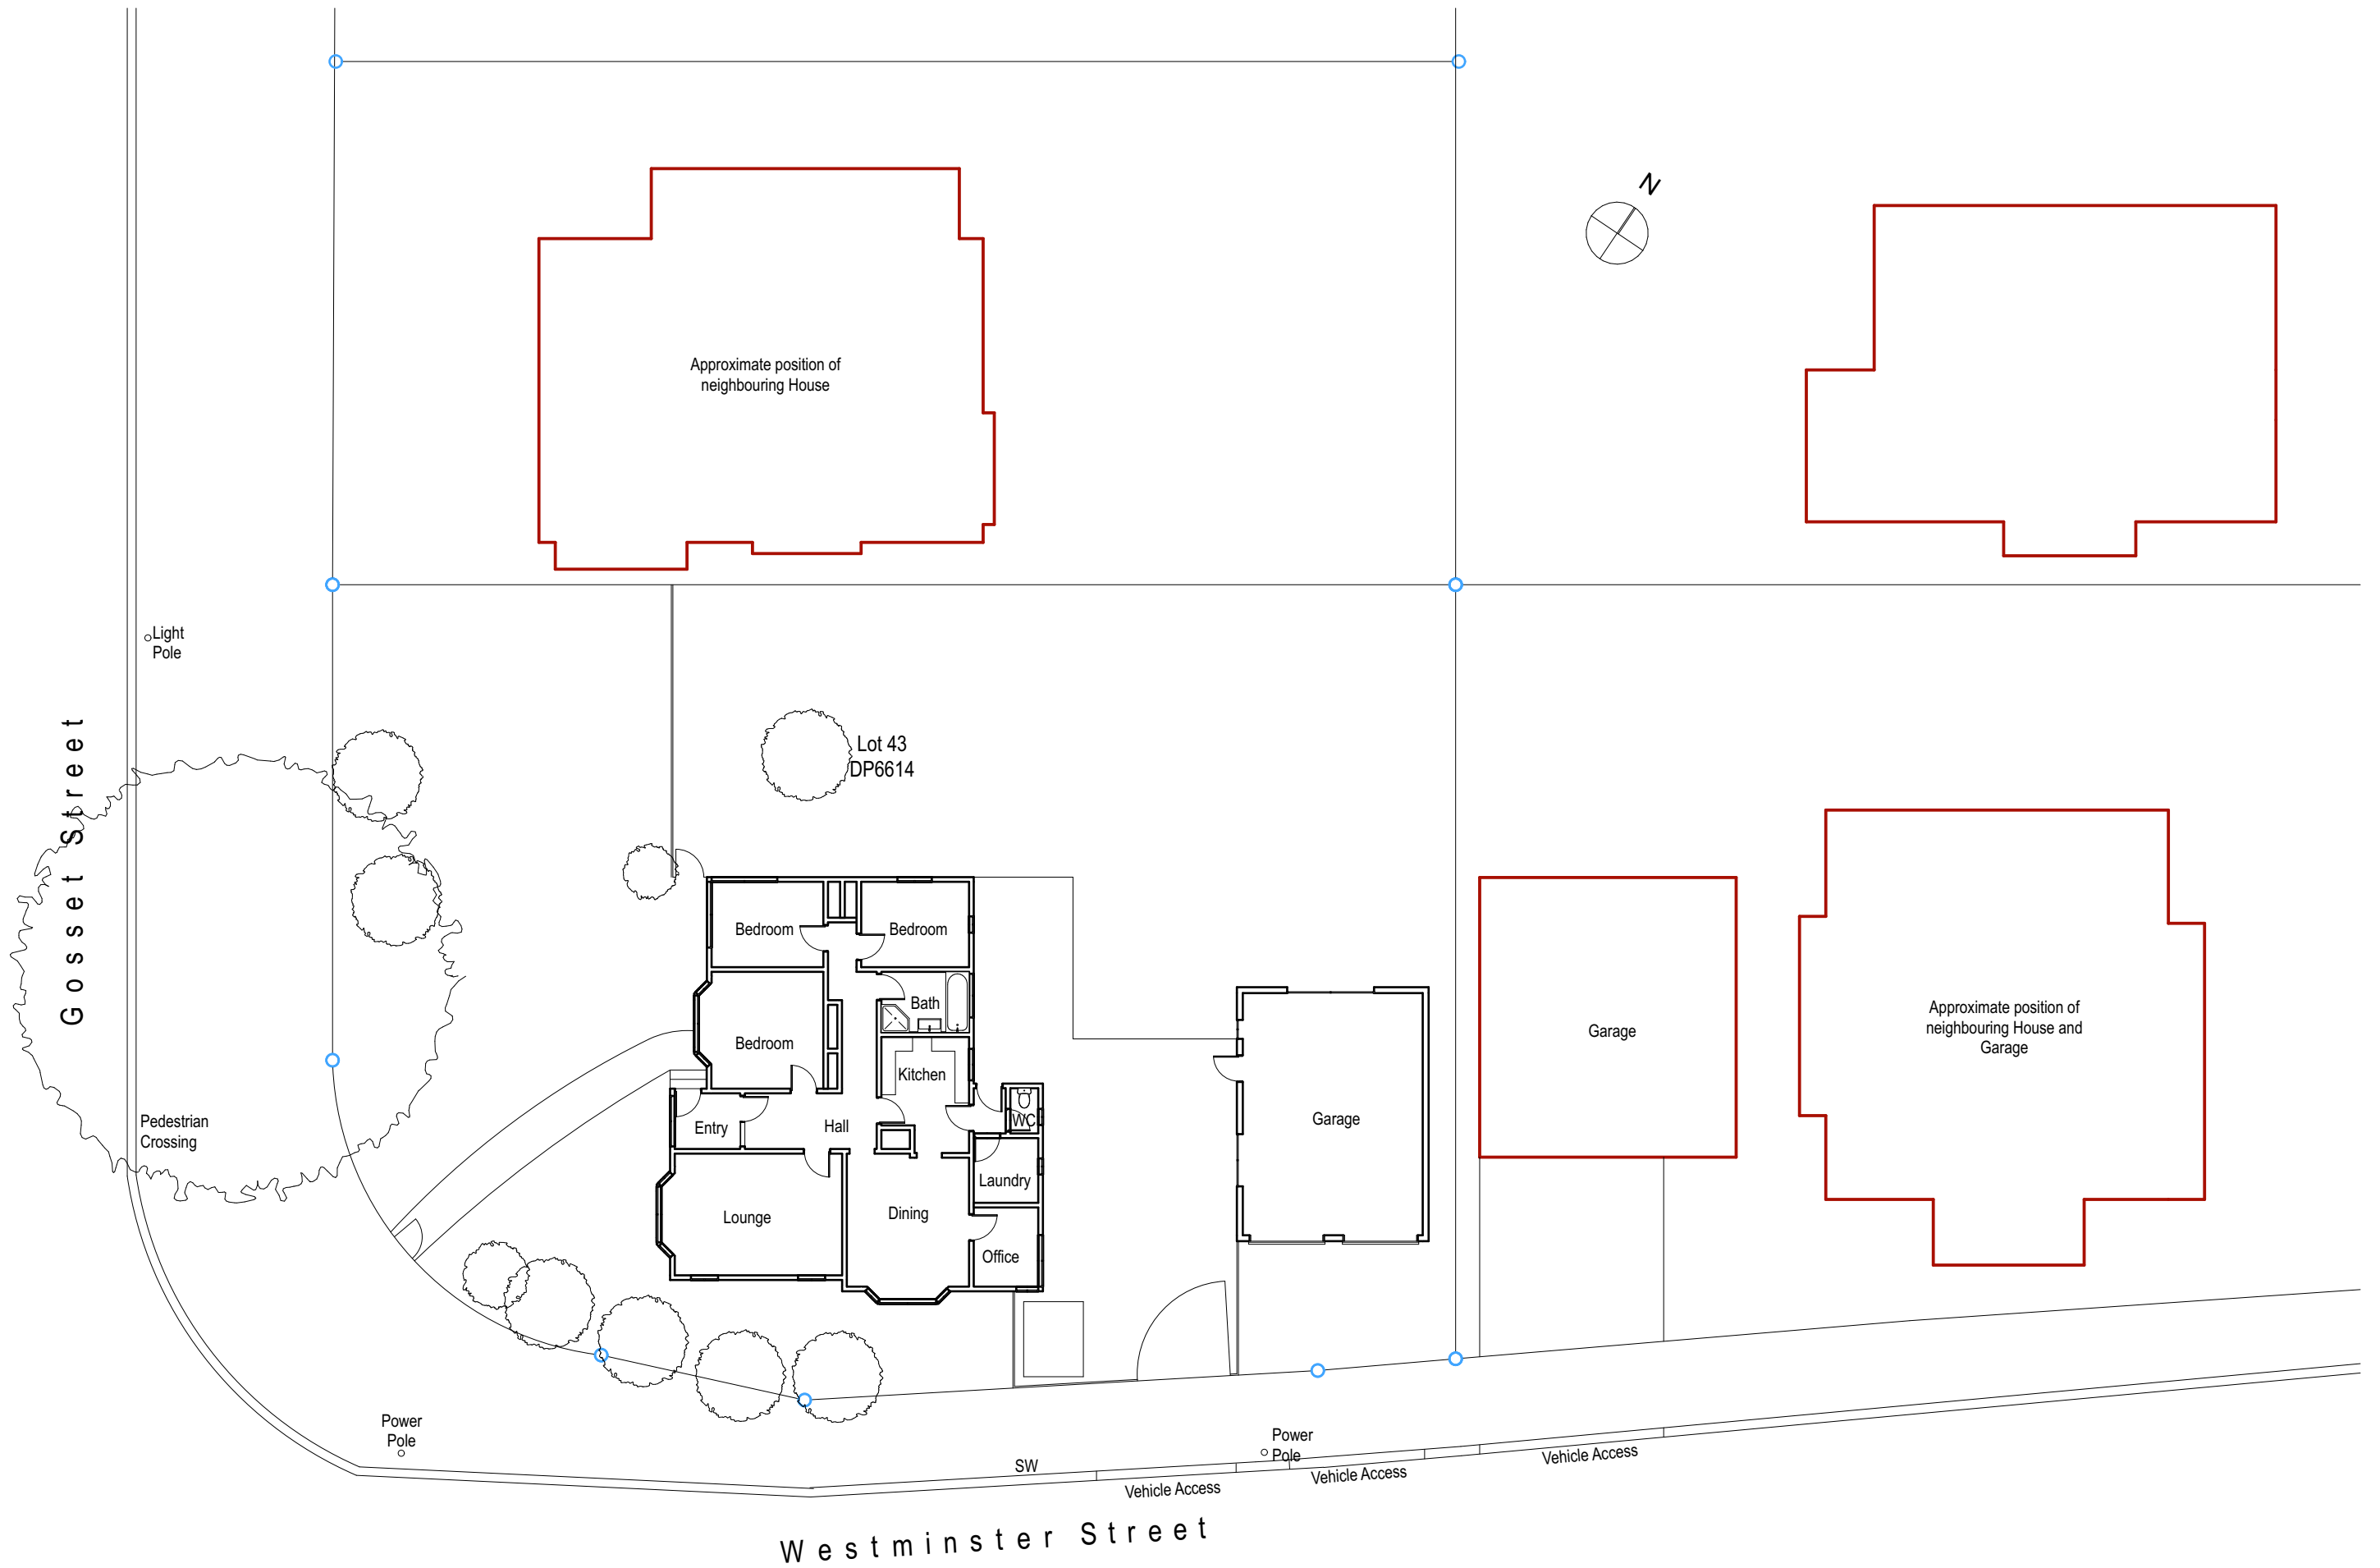
**A1.1**

**Site Areas**  
**2 Gosset Street**  
Site Area 493.08m<sup>2</sup>  
35% = 172.55m<sup>2</sup>  
40% = 197.232

Ground Floor 164.52m<sup>2</sup>  
First Floor 63.31m<sup>2</sup>  
Total 227.83m<sup>2</sup>

**Site Description**  
Site Information Lot 43 DP6614  
Site Area 905m<sup>2</sup>  
CCC District Plan Zone RSDT  
Flood Zone No  
Notation CA11  
Liquefaction Hazard 400m<sup>2</sup> Minimum  
Site Area 400m<sup>2</sup> Minimum  
Building Height 8m max  
Site Coverage 35%  
Min Outdoor living space 50m<sup>2</sup>, 4m Dimension  
Road Boundary Set Back 4.5m

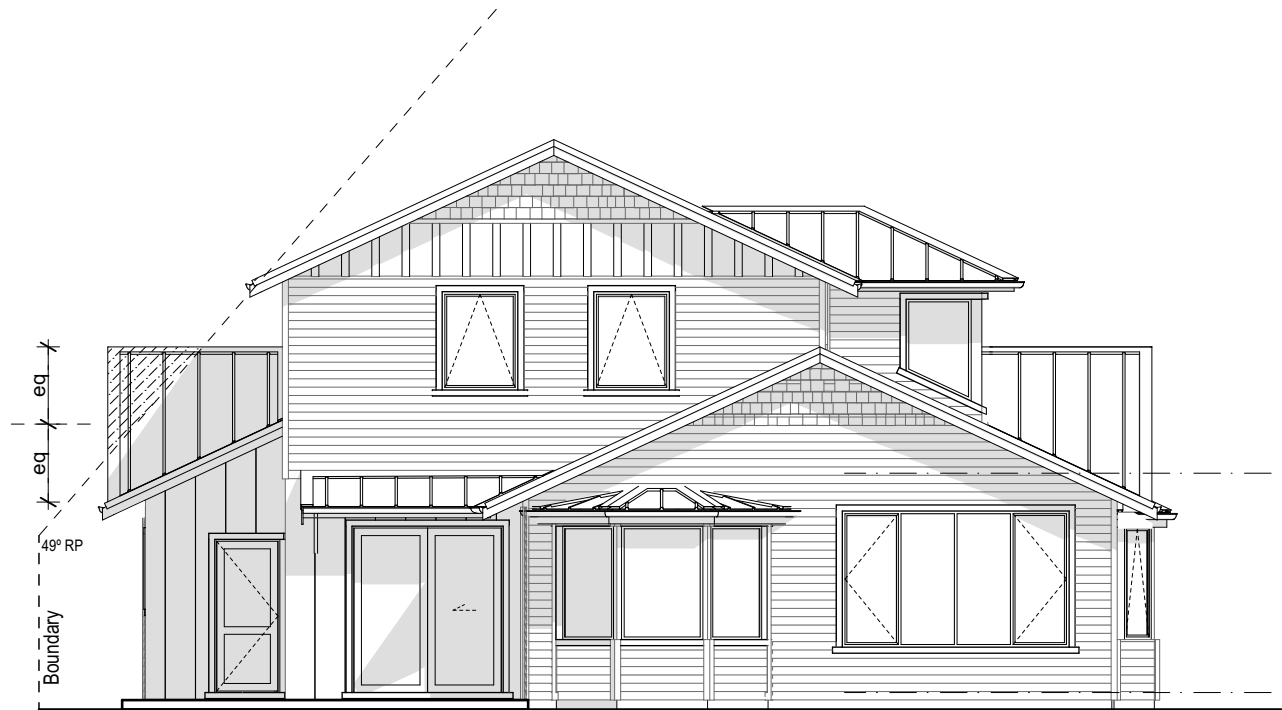
North Elevation - 2 Gosset Street  
1:100

Intrusion through recession plane
